# Property Inspection Report

1301 Belmeade Dr, Champaign, IL 61821  
Inspection prepared for: Jeremy Hunt  
Date of Inspection: 1/6/2026 Time: 8:30 AM  
Age of Home: 1959 Size: 2382  
Order ID: 28315

Inspector: Tim Haas

*P*ristine  
Inspections & Testing

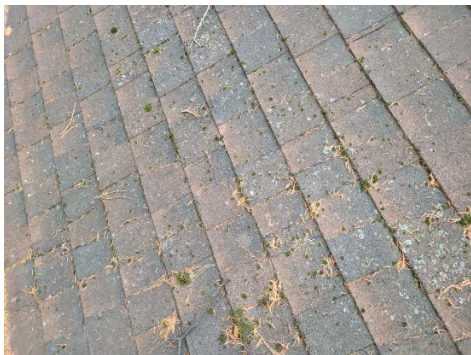
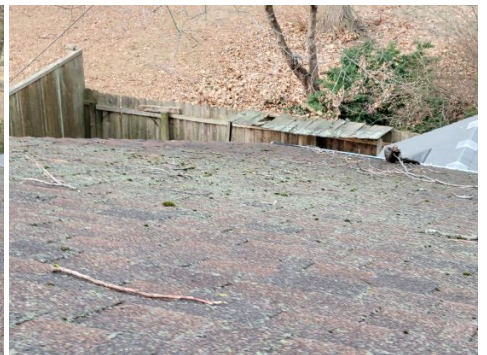
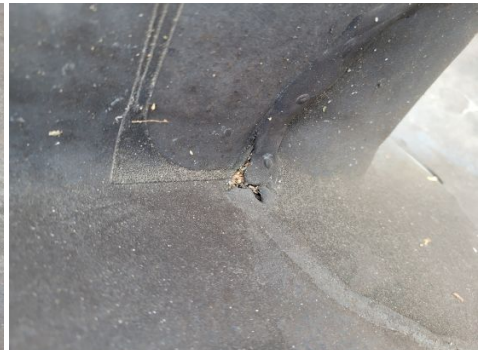
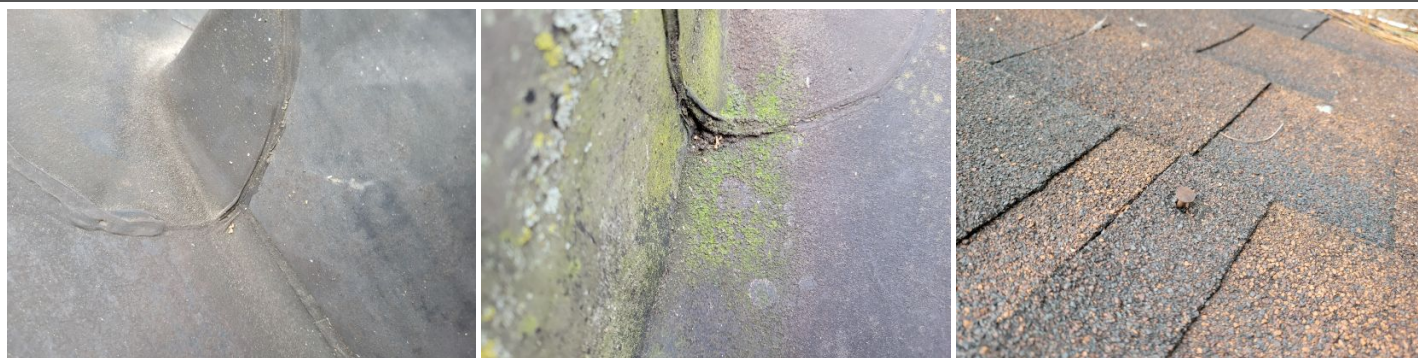
| Roof | | |
|---|---|---|
| Page 23 Item: 2 | Roof Covering | <p>2.3. Moss growth noted on the roofing surface. Moss growth deteriorates the roofing material and will eventually cause a roof leak to occur. All moss growth should be gently cleaned from the roof. Chemical treatments are available to help reduce the reoccurrence of this condition.</p> <p>2.4. Loose edges noted in the single ply material. If the edges are not properly sealed a roof leak may occur. Repairs are recommended.</p> <p>2.5. Nail pops were observed on the roof surface. This occurs when a roofing nail backs out of the wood sheathing causing the shingle above it to lift up. Nail pops make the shingles prone to wind damage, so repairs are recommended.</p> |

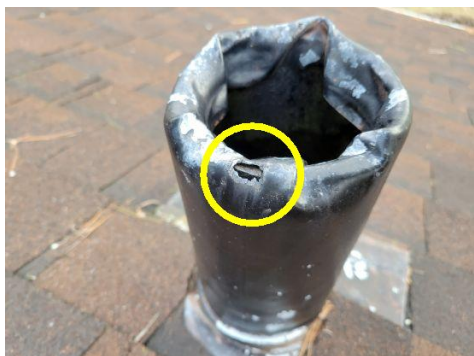
| Page 24 Item: 3 | Flashing | 3.1. Lead flashing is worn/damaged. Replacement flashing appears to be needed to eliminate the possibility of water penetration. |

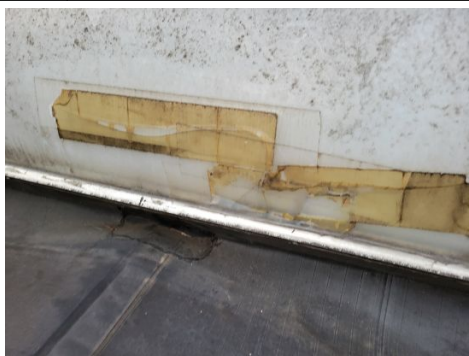
| Page 24 Item: 4 | Skylights | 4.2. Plastic is heavily cracked but does not appear to be leaking. Monitor and replace on an as needed basis. |

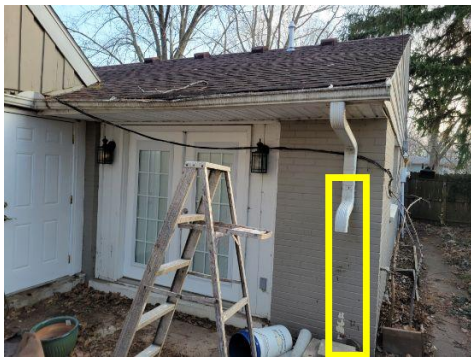
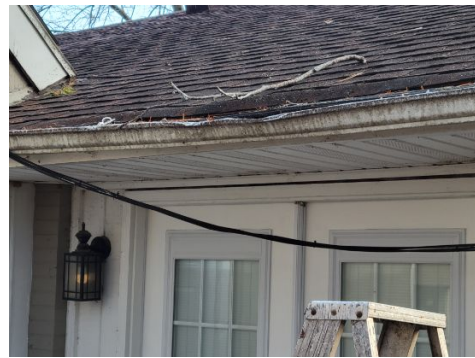
| Page 25 Item: 7 | Gutters / Downspouts | <p>7.3. Missing downspout section was observed, so replace the missing section to ensure proper drainage away from the foundation.</p> <p>7.4. Sagging gutter noted. Repairs are recommended to ensure proper drainage.</p> |

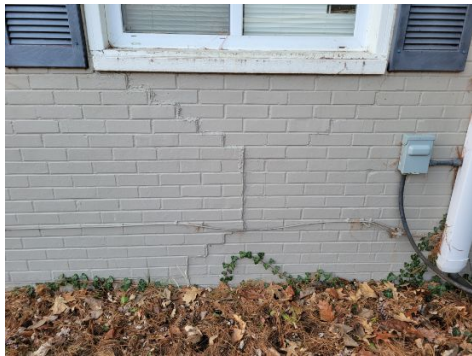
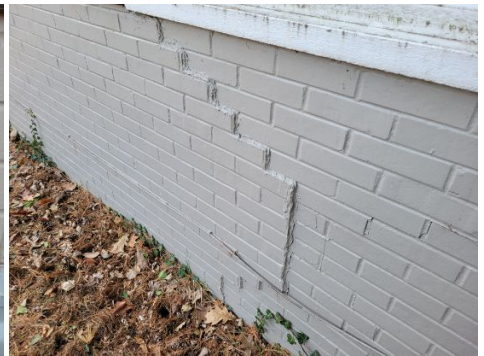
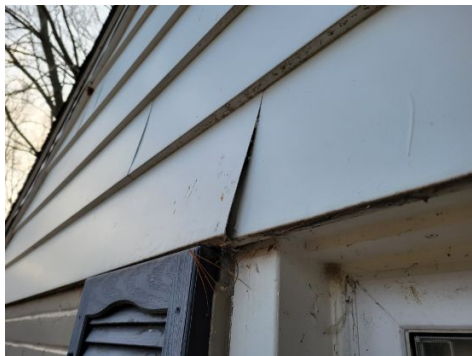
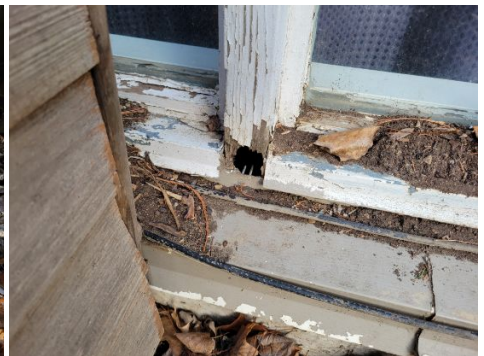
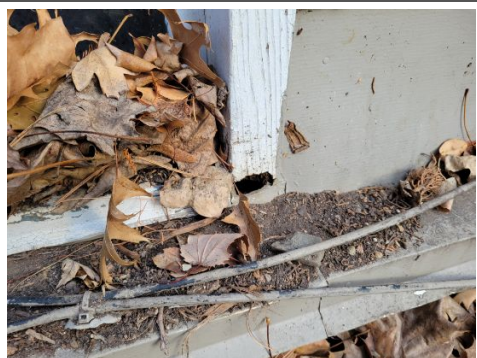
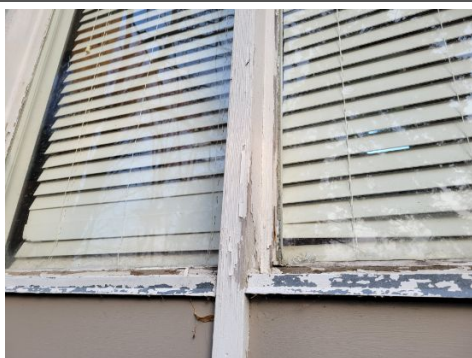
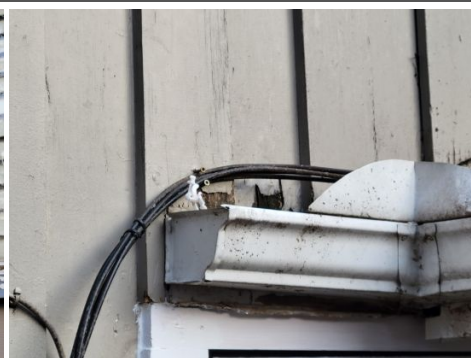
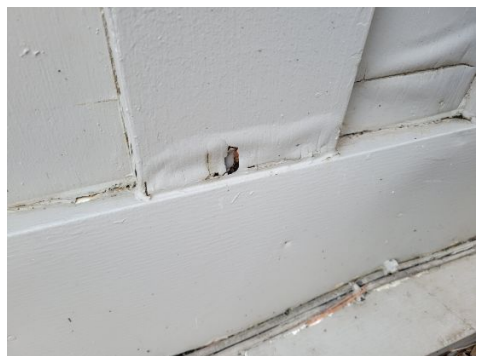
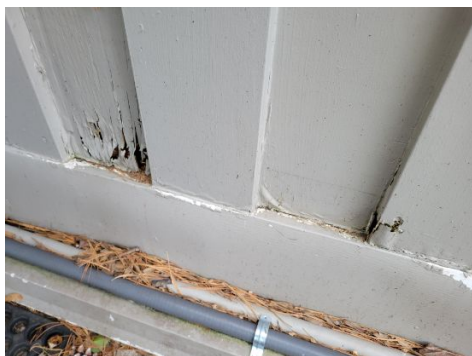
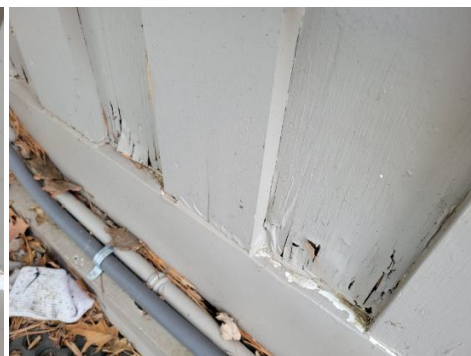
Page 26 Item: 1

- 1.1. Cracked bricks/mortar noted. Further evaluation by a qualified brick mason is recommended and repairs made if necessary.
- 1.2. Loose siding observed. The siding should be properly secured to prevent damage and allow it protect the house.
- 1.3. Moisture damage noted on the wood, so further evaluation is recommended and repairs made as needed.
- 1.4. Peeling paint was observed, so paint repairs are recommended. If soft wood is discovered when preparing the surface for painting, replace the wood before painting.

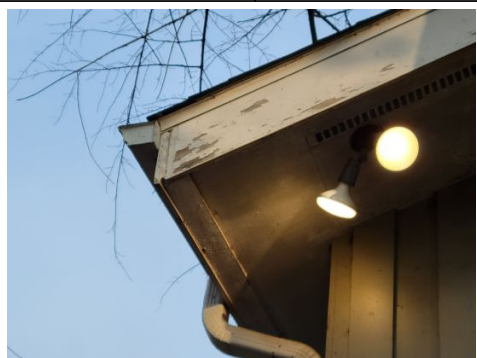
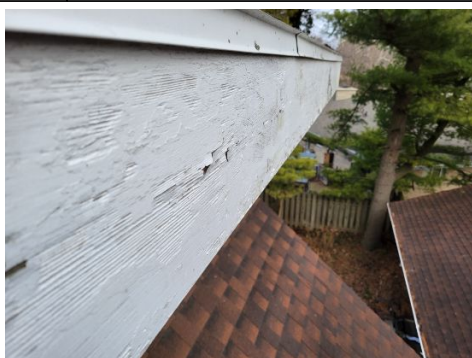
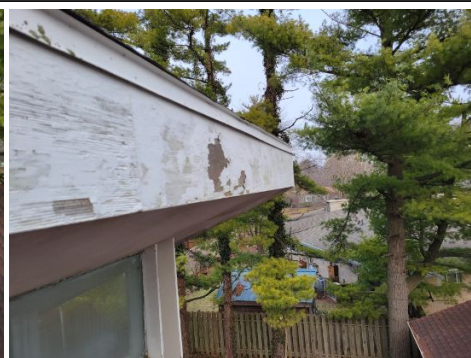
2.1. Peeling paint was observed on this area. Paint repairs are recommended at this time to properly protect it from the elements. Soft wood may be discovered during the surface preparation. If so, wood repairs will need to be completed prior to the application of the finish coat of paint.

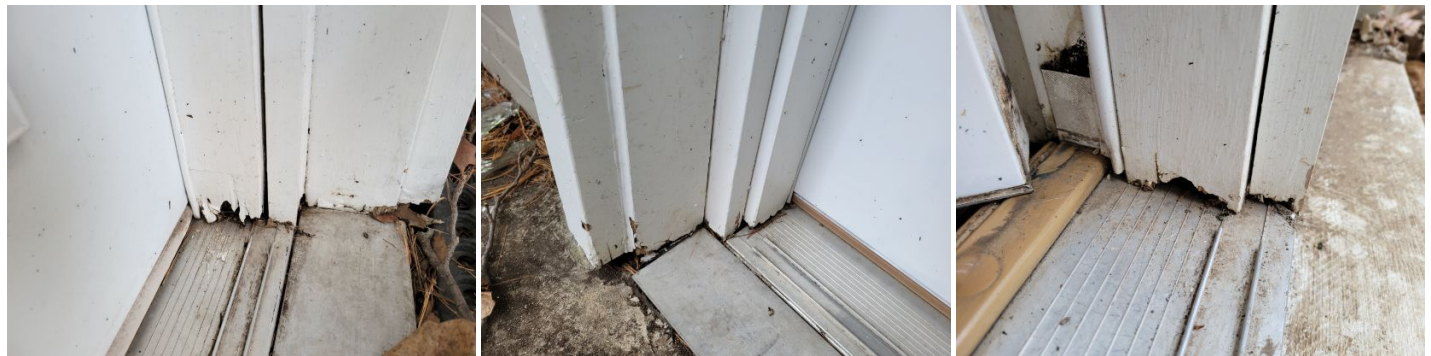
| Page 28 Item: 5 | Entry Doors | <p>5.1. Moisture damage was observed on the door jambs. Repairs are recommended to correct this condition.</p> <p>5.2. Missing strike plate noted for the deadbolt. Failure to install a strike plate can lead to door jamb damage, so strike plate installation is recommended at this time.</p> <p>5.3. Rubbing/sticking east door observed. Repairs are recommended to allow the door to open/close easily.</p> |

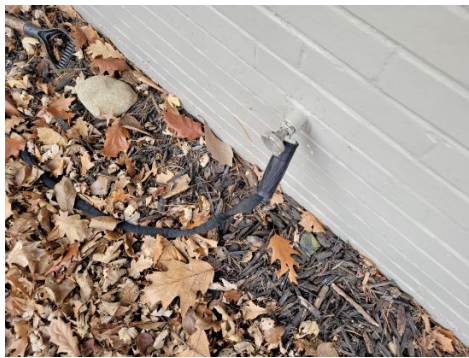
| Page 29 Item: 8 | Exterior Faucets | <p>8.1. The front faucet handle will not turn, making the faucet not operational. Further evaluation is recommended, and repairs made on an as needed basis.</p> |

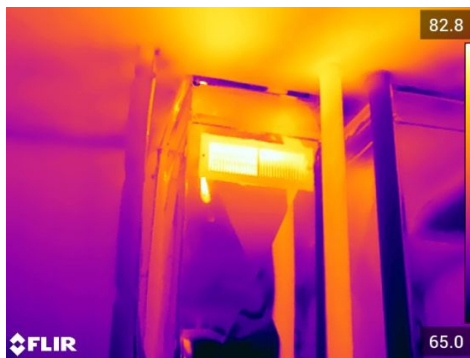
| Page 32 Item: 12 | Garage Heat | 12.1. Register observed, which is connected to the house HVAC system. This has been prohibited since 1983 since fumes from the garage can enter the living space. Sealing the register or removing it is recommended. |

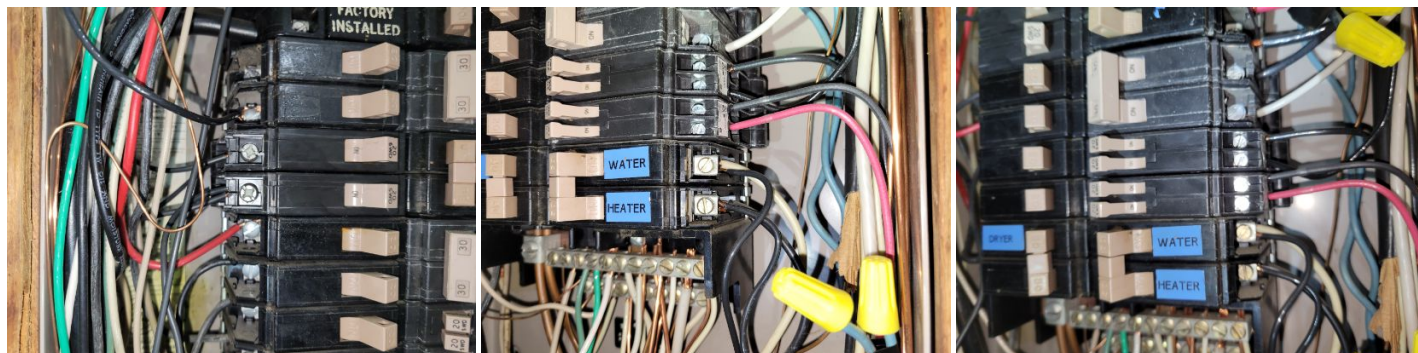
| Page 35 Item: 5 | Breakers/Fuses | <p>5.1. <b>Double taps</b> present in the panel. This means that 2 wires are improperly attached to a breaker that is not "U.L. Approved" for such a connection. Repairs are recommended.</p> <p>5.2. Improper shared neutral condition noted in the electrical panel. Two circuit breakers in an electrical panel can share one neutral wire as long as the breakers are not on the same "leg" of power. Evaluation and/or repairs by a qualified electrician is recommended.</p> |

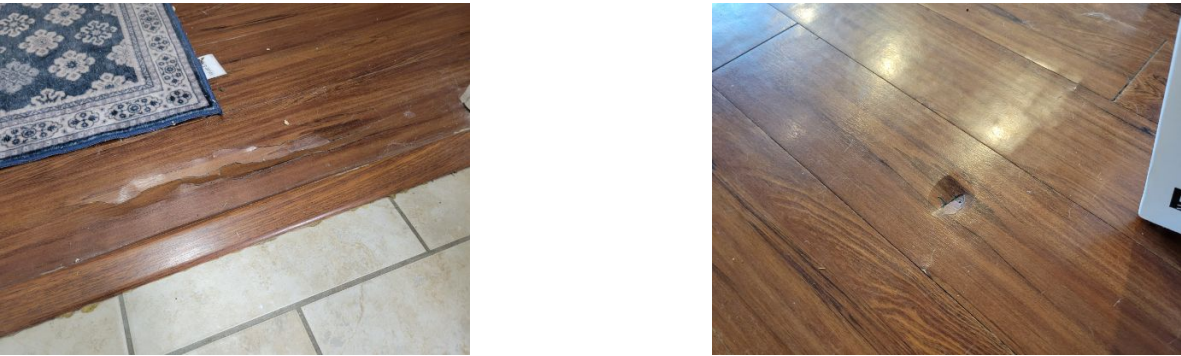
| Page 46 Item: 4 | Floors | 4.1. Damaged flooring material observed. Flooring repairs are recommended. |

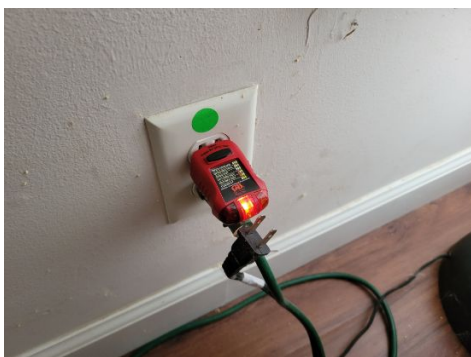
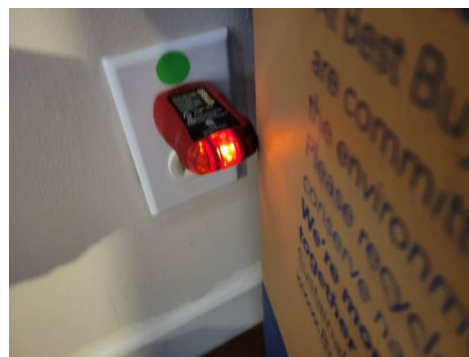
| Page 48 Item: 8 | Electrical | <p>8.1. Open ground condition found on many of the outlets in this house. This condition is common due to the wiring, hot &amp; neutral wires only, used during the time period the house was constructed and the desire to change or decorate for modern times. The house's original 2-prong non grounded outlets have been replaced with a 3-prong outlet but a ground wire doesn't exist which causes the issue. Just because an electric panel has been upgraded and some wiring has been changed does not guarantee that all of the wiring has been replaced with wiring that includes a ground wire. The wiring is still safe, but is identified in the report since some appliances (refrigerators, microwaves, surge protectors, desk top computers, clothes washers, etc.) do need the ground to be functional in the outlet to work safely/properly. In most cases, the 3-prong outlets have been installed out of convenience and/or cost and we are identifying the condition for you since you can not tell if it is grounded by looking at it. A 2-prong outlet is harder to find and usually costs 4 times the price of a 3-prong outlet which makes it the choice of most homeowners changing outlets. Replacing the 3-prong outlets with a 2-prong or <b>GFCI</b> outlets is usually the proper solution.</p> <p>As an additional note, the standard sales contract for Champaign County has verbiage that states that it is not required that 3-prong outlets not served by a ground wire be grounded to be considered in normal working condition since this comes up on old houses very frequently. We are notifying you to make sure if you have an item that needs a ground that you are aware of which outlets to use.</p> <p>Areas around water where a GFCI is recommended will still show up in the detail as open ground.</p> |

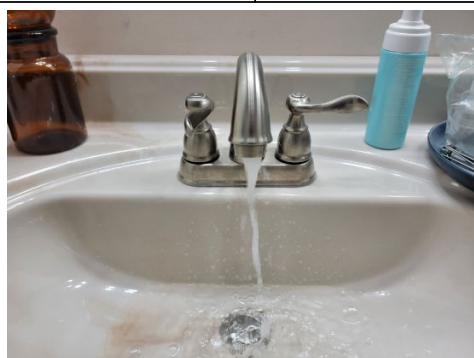
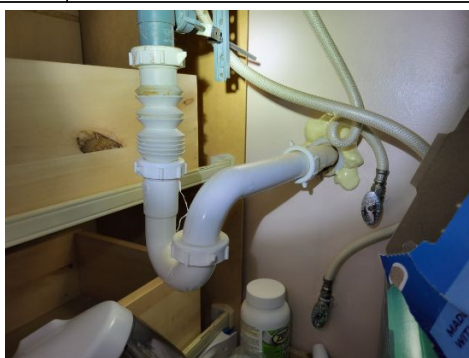
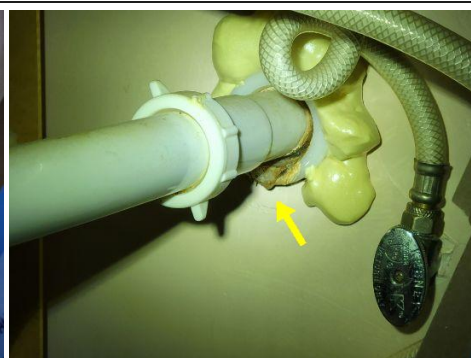
| Page 56 Item: 9 | Sink/Basin | <p>9.1. Low water flow was noted while testing the left faucet. Repairs are recommended to ensure adequate water flow is maintained at this unit. Further evaluation by a qualified plumber is recommended and repairs made as needed.</p> <p>9.2. Flexible drain line in use on the drain lines. Flexible drain lines are very susceptible to developing leaks and are, therefore, a poor and improper material for drain lines or traps. All drainage pipes and fittings should be smooth-wall material with no ridges, ledges or bends that will slow down or stop flow. Flexible material is unsanitary and has a greater tendency to clog. Further evaluation by a qualified plumber is recommended and repairs made as needed.</p> <p>9.3. Leaking drain lines noted under the sink. Repairs are needed to correct this condition.</p> |

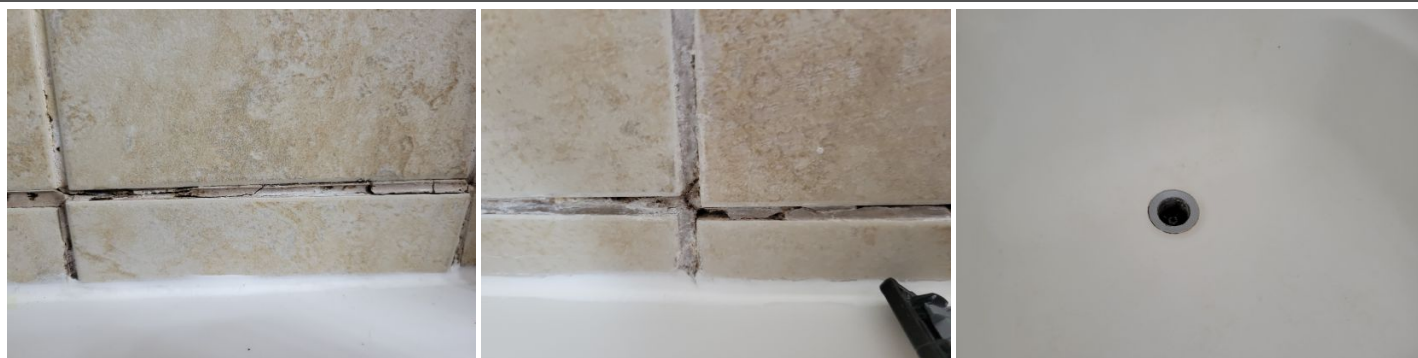
| Page 57 Item: 11 | Tub & Tub/Shower | <p>11.2. Loose tile and cracked mortar observed around the tub. Tile repairs are recommended to ensure water damage does not occur to the areas behind the tile.</p> <p>11.3. Missing tub stopper noted, so a replacement stopper is needed at this time. Due to this, the plumbing drains were not tested with our standard testing process.</p> |

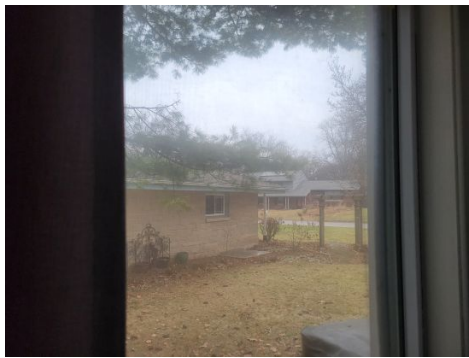
| Page 61 Item: 6 | Windows | 6.2. Fogged glass pane is present in the northwest bedroom due to a broken seal. While a fogged glass pane does not allow water or air to pass through, it is a nuisance. Glass pane replacement is recommended to correct this problem, but not required. |

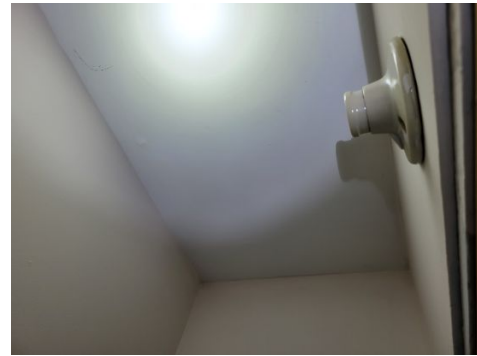
| Page 62 Item: 9 | Lights, Switches | <p>9.2. Inoperative closet light observed in the southwest bedroom. The pull chain did not operate the light when tested. The bulb should be replaced first and if the light still fails to operate, then further evaluation is needed and repairs made as necessary.</p> <p>9.3. Missing light bulb observed in the northwest bedroom closet, so the light was not tested. Replace the bulb and test the light to ensure it is functional.</p> |

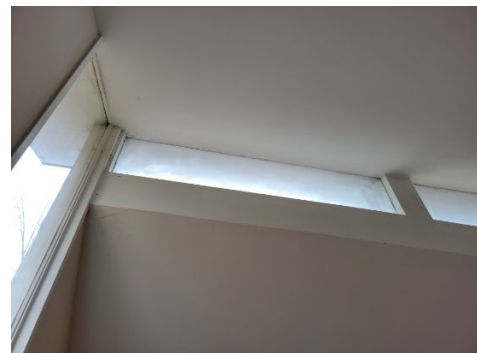
| Page 63 Item: 5 | Windows | <p>5.1. Fogged glass pane is present due to a broken seal. While a fogged glass pane does not allow water or air to pass through, it is a nuisance. Glass pane replacement is recommended to correct this problem, but not required.</p> <p>5.2. Fixed pane windows noted in this room which does not allow an escape route. Adding an escape route is recommended.</p> |

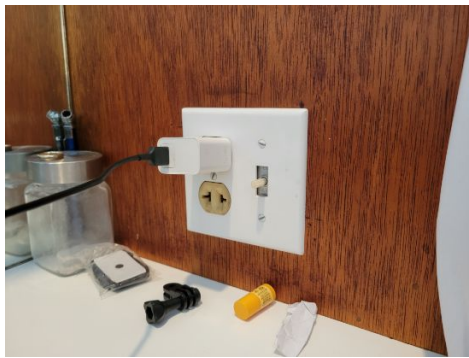
| Page 63 Item: 8 | Lights, Switches | 8.2. Missing dimmer knob. Replacement knob is recommended to allow easy control of the light. |

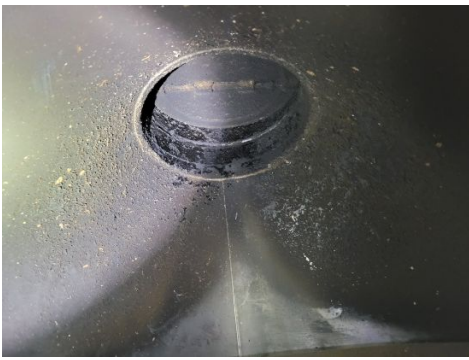
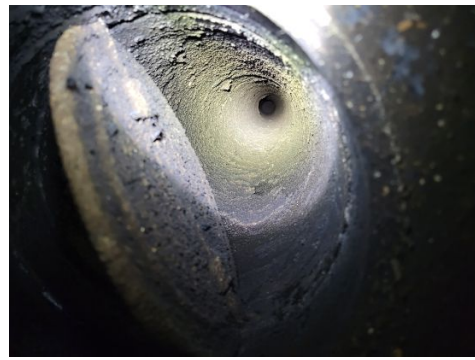
| Page 65 Item: 2 | Flue | 2.1. Recommend cleaning/sweeping the flue. I recommend having this cleaning performed by a qualified chimney sweep prior to burning any fires in this fireplace. |

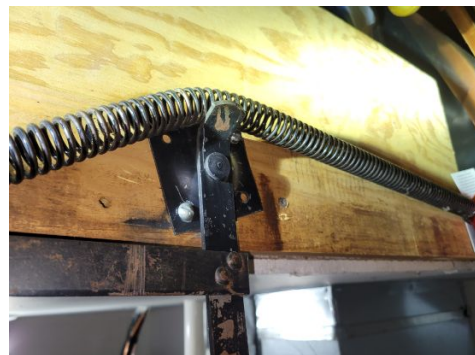
| Page 66 Item: 2 | Access | 2.1. Missing nails noted securing the stairs. Most pull down stairs require nails in the holes of the spring brackets for additional support, so add nails per manufacturer's guidelines.<br>2.2. Loose bracket noted at the top of the stairs, so repairs are recommended. |

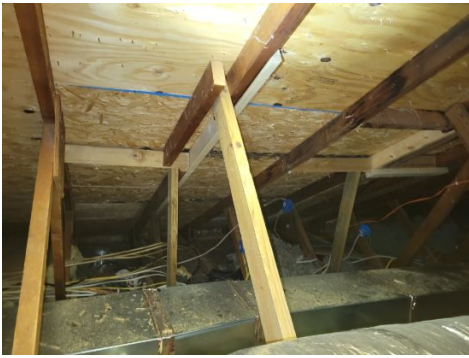
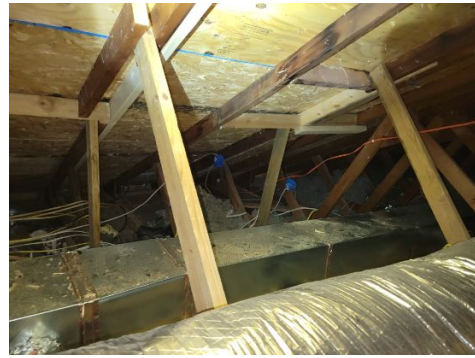
| Page 66 Item: 3 | Roof Framing | 3.1. Modified wood trusses observed. The inner web has been cut/moved on the trusses in the main portion of the attic. On this type of framing system, no modifications are typically permitted per the manufacturer's specifications. Further evaluation by a qualified carpenter is recommended and repairs made as needed. |

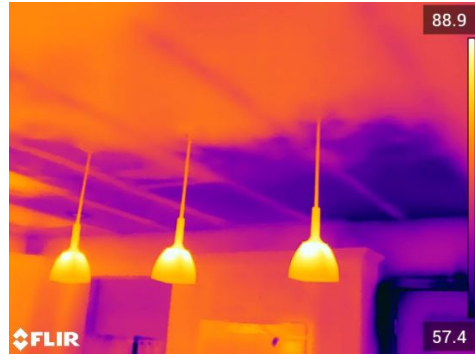
Page 67 Item: 6

6.1. Insulation voids found using an Infrared camera and verified while inspecting the attic. Insulation installation is recommended.

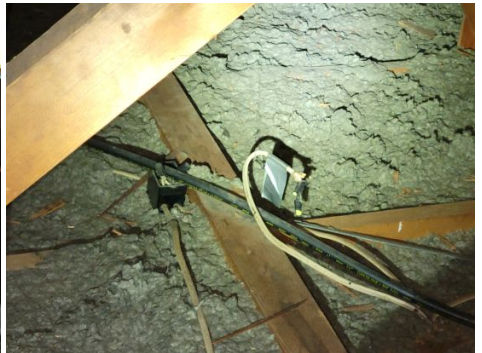
Page 68 Item: 8

8.1. Uncovered junction boxes observed which leaves the wiring susceptible to damage. Install a proper cover on each box to correct this deficiency. Not all of the boxes may be pictured.

8.2. Improper wire terminations observed. All wire terminations should be contained in a properly sized, securely mounted, covered junction box. Repairs are recommended as a safety precaution.

8.3. Missing cover plate noted. All switches and outlet boxes should have covers installed on them at all times as a safety precaution. If not repaired, a person can come into contact with energized electrical components.

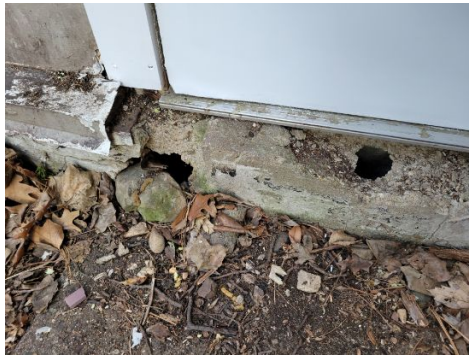
| Page 69 Item: 2 | Foundation Observations | 2.1. Damaged block observed on the wall of the foundation. A qualified brick mason should be contacted to provide further inspection and repairs made as needed. |

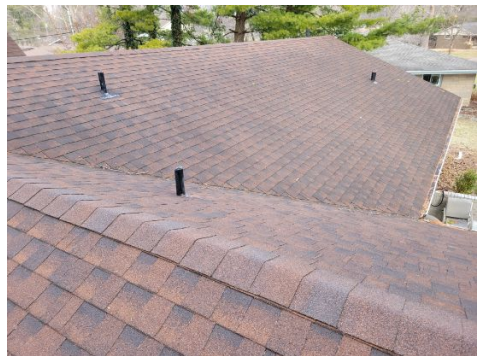
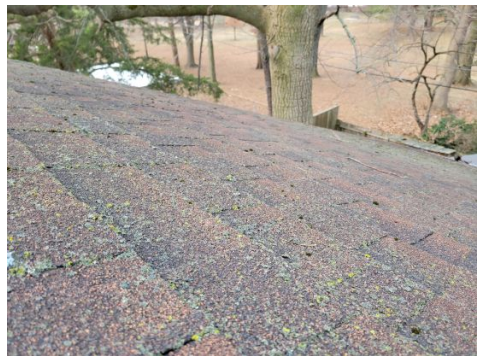
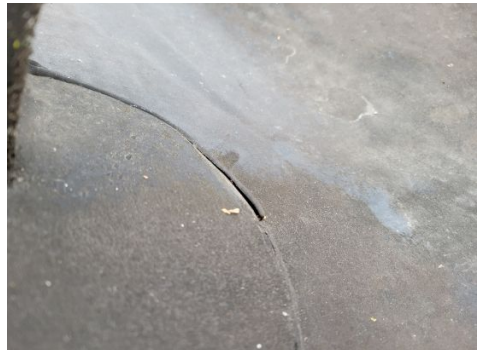
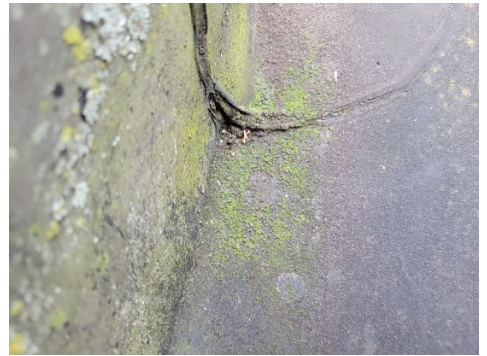
2.3. Moss growth noted on the roofing surface. Moss growth deteriorates the roofing material and will eventually cause a roof leak to occur. All moss growth should be gently cleaned from the roof. Chemical treatments are available to help reduce the reoccurrence of this condition.

2.4. Loose edges noted in the single ply material. If the edges are not properly sealed a roof leak may occur. Repairs are recommended.

2.5. Nail pops were observed on the roof surface. This occurs when a roofing nail backs out of the wood sheathing causing the shingle above it to lift up. Nail pops make the shingles prone to wind damage, so repairs are recommended.

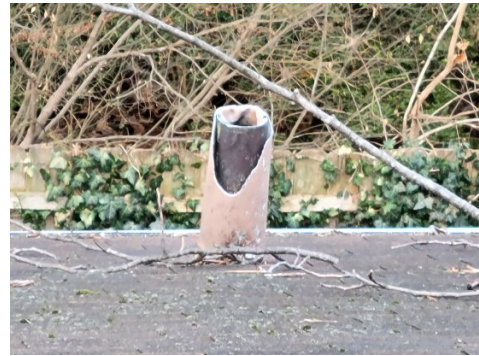
3.1. Lead flashing is worn/damaged. Replacement flashing appears to be needed to eliminate the possibility of water penetration.

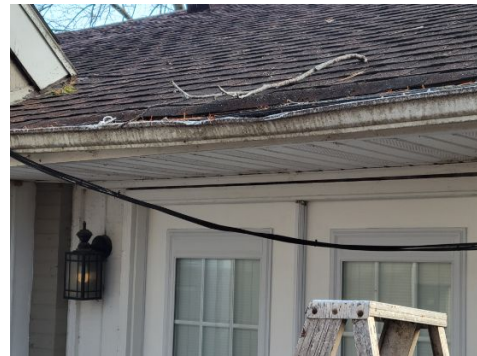
7.3. Missing downspout section was observed, so replace the missing section to ensure proper drainage away from the foundation.

7.4. Sagging gutter noted. Repairs are recommended to ensure proper drainage.

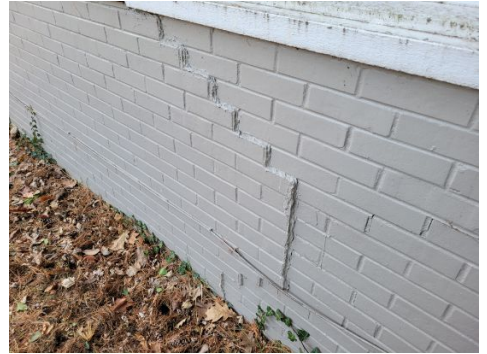
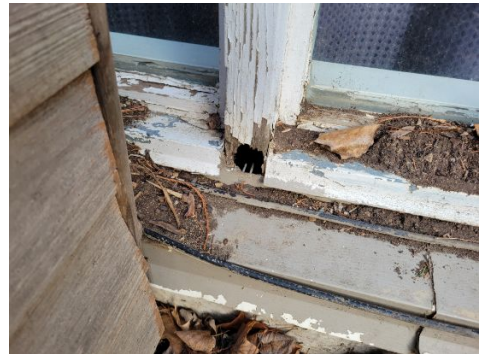
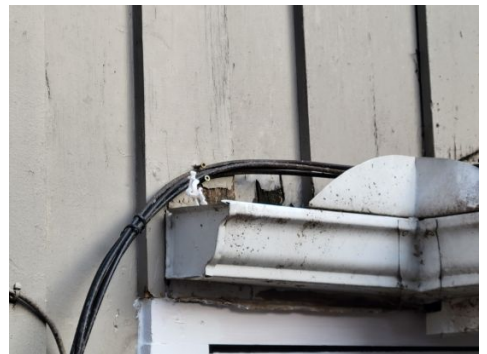
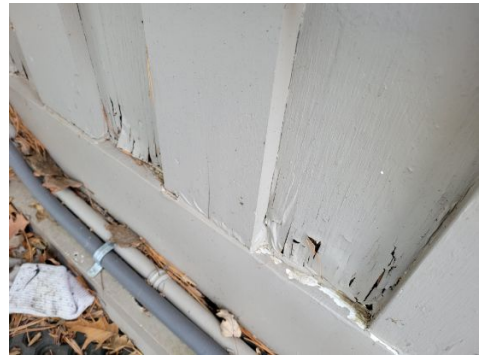
- 1.1. Cracked bricks/mortar noted. Further evaluation by a qualified brick mason is recommended and repairs made if necessary.
- 1.2. Loose siding observed. The siding should be properly secured to prevent damage and allow it protect the house.
- 1.3. Moisture damage noted on the wood, so further evaluation is recommended and repairs made as needed.
- 1.4. Peeling paint was observed, so paint repairs are recommended. If soft wood is discovered when preparing the surface for painting, replace the wood before painting.

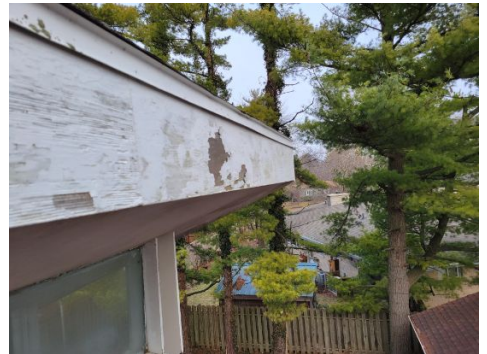
2.1. Peeling paint was observed on this area. Paint repairs are recommended at this time to properly protect it from the elements. Soft wood may be discovered during the surface preparation. If so, wood repairs will need to be completed prior to the application of the finish coat of paint.

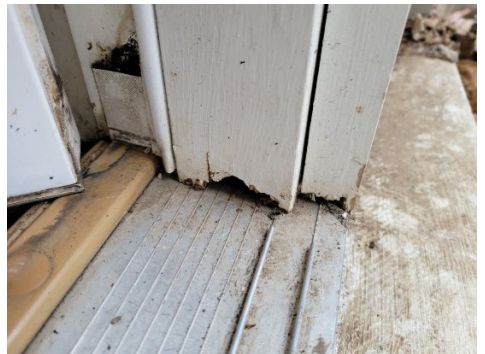
5.1. Moisture damage was observed on the door jambs. Repairs are recommended to correct this condition.

5.2. Missing strike plate noted for the deadbolt. Failure to install a strike plate can lead to door jamb damage, so strike plate installation is recommended at this time.

5.3. Rubbing/sticking east door observed. Repairs are recommended to allow the door to open/close easily.

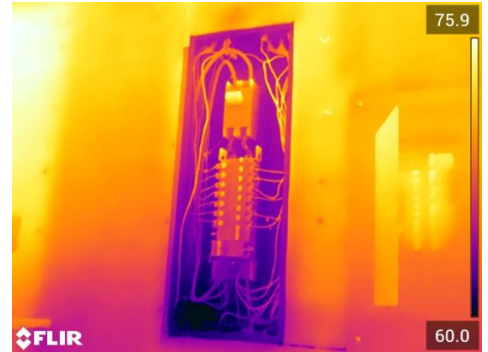
2.2. Missing 3 panel cover screws noted. Any missing screws should be replaced with blunt end screws to ensure that the panel is held securely in place.

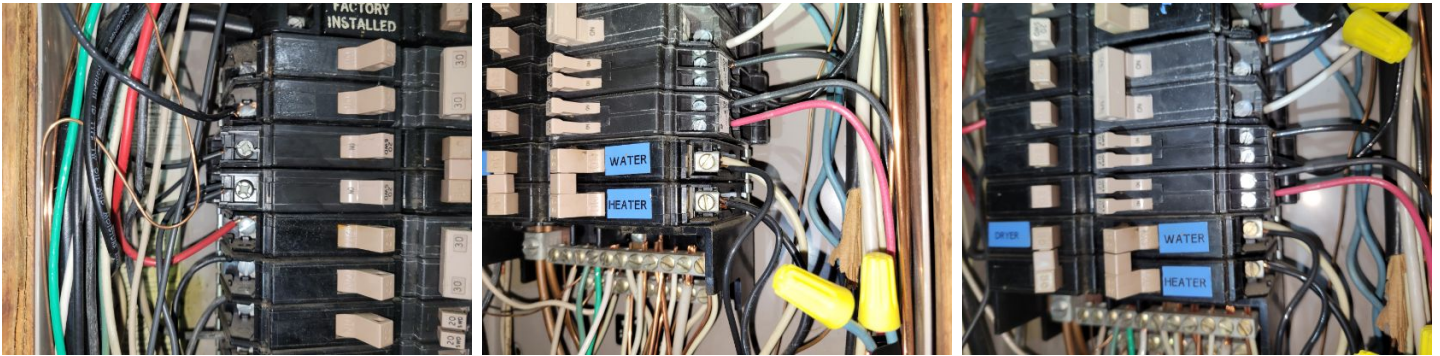
5.2. Improper shared neutral condition noted in the electrical panel. Two circuit breakers in an electrical panel can share one neutral wire as long as the breakers are not on the same "leg" of power. Evaluation and/or repairs by a qualified electrician is recommended.

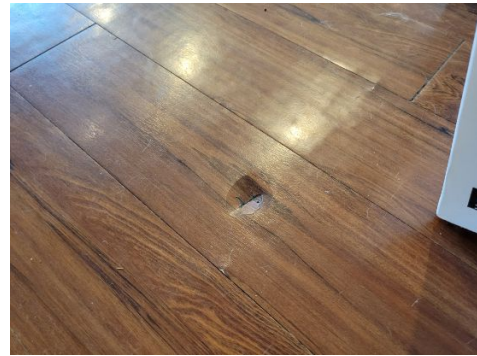
4.1. Damaged flooring material observed. Flooring repairs are recommended.

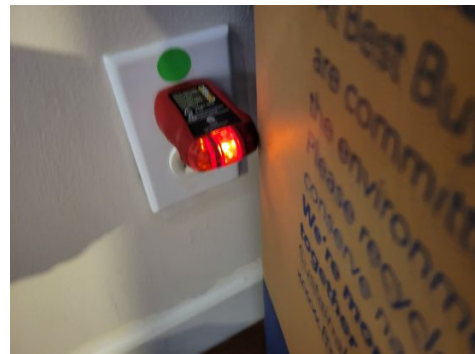
Areas around water where a GFCI is recommended will still show up in the detail as open ground.

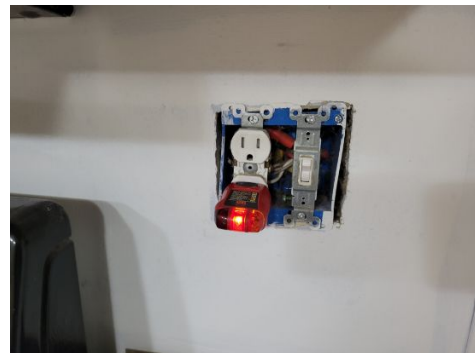
9.3. Missing cover plates noted since the room is being painted. All switches and outlet boxes should have covers installed on them at all times as a safety precaution. A person can come into contact with energized electrical components, so replacing them once painting is completed is recommended.

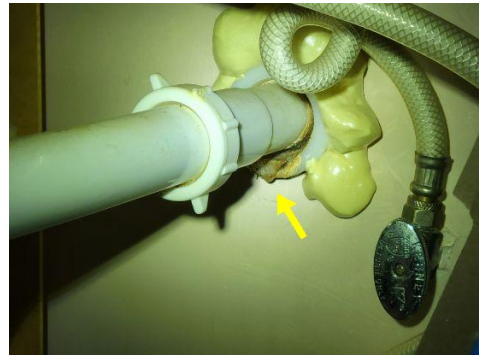
9.3. Leaking drain lines noted under the sink. Repairs are needed to correct this condition.

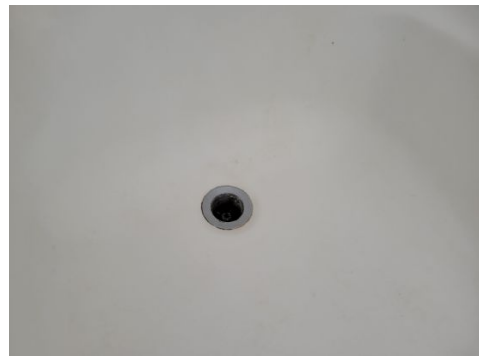
11.3. Missing tub stopper noted, so a replacement stopper is needed at this time. Due to this, the plumbing drains were not tested with our standard testing process.

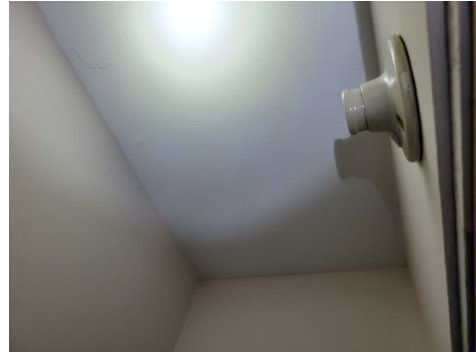
9.3. Missing light bulb observed in the northwest bedroom closet, so the light was not tested. Replace the bulb and test the light to ensure it is functional.

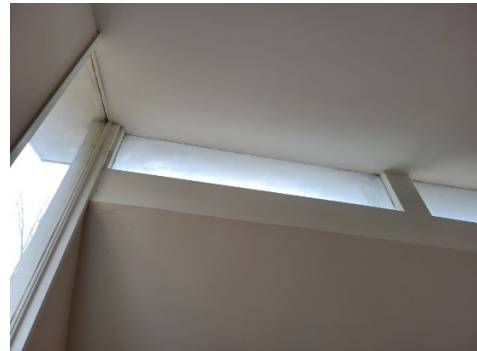
5.2. Fixed pane windows noted in this room which does not allow an escape route. Adding an escape route is recommended.

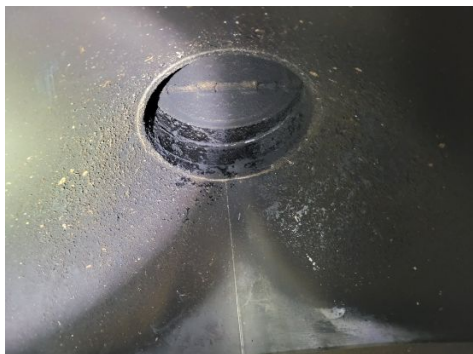
2.1. Recommend cleaning/sweeping the flue. I recommend having this cleaning performed by a qualified chimney sweep prior to burning any fires in this fireplace.

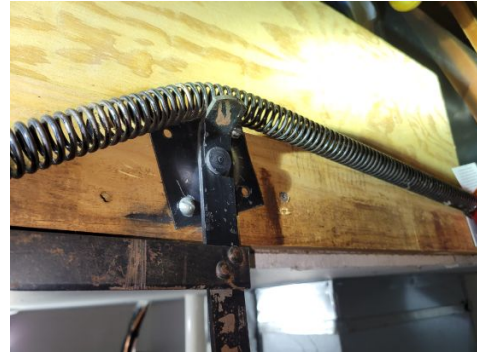
2.2. Loose bracket noted at the top of the stairs, so repairs are recommended.

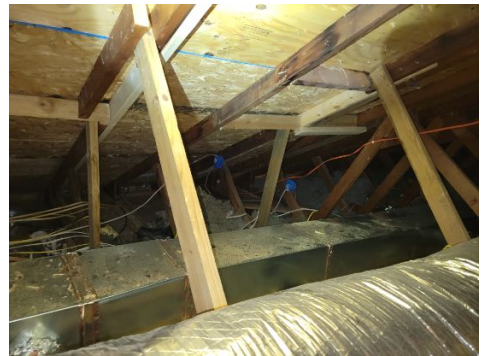
3.1. Modified wood trusses observed. The inner web has been cut/moved on the trusses in the main portion of the attic. On this type of framing system, no modifications are typically permitted per the manufacturer's specifications. Further evaluation by a qualified carpenter is recommended and repairs made as needed.

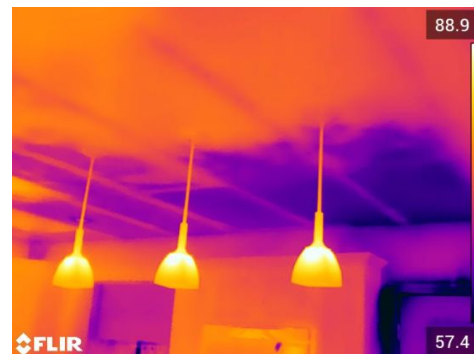
Insulation installation is recommended.

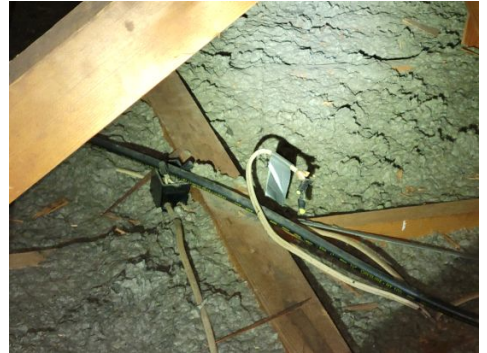
- 8.1. Uncovered junction boxes observed which leaves the wiring susceptible to damage. Install a proper cover on each box to correct this deficiency. Not all of the boxes may be pictured.
- 8.2. Improper wire terminations observed. All wire terminations should be contained in a properly sized, securely mounted, covered junction box. Repairs are recommended as a safety precaution.
- 8.3. Missing cover plate noted. All switches and outlet boxes should have covers installed on them at all times as a safety precaution. If not repaired, a person can come into contact with energized electrical components.
