# Property Inspection Report

1301 Belmeade Dr, Champaign, IL 61821  
Inspection prepared for: Jeremy Hunt  
Date of Inspection: 1/6/2026 Time: 8:30 AM  
Age of Home: 1959 Size: 2382  
Order ID: 28315

Inspector: Tim Haas

*P*ristine  
Inspections & Testing

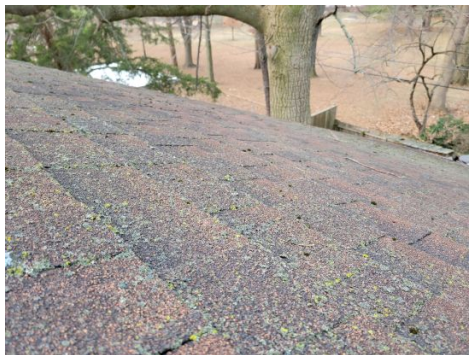
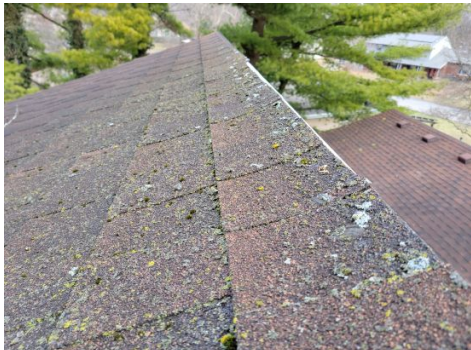
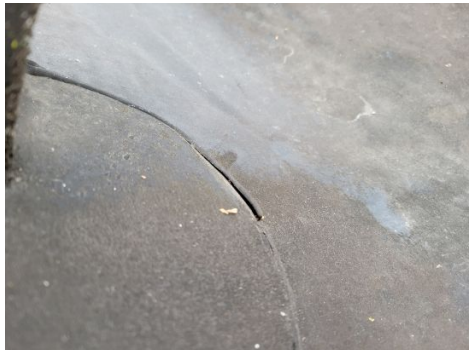
| Roof | | |
|---|---|---|
| Page 23 Item: 2 | Roof Covering | <p>2.3. Moss growth noted on the roofing surface. Moss growth deteriorates the roofing material and will eventually cause a roof leak to occur. All moss growth should be gently cleaned from the roof. Chemical treatments are available to help reduce the reoccurrence of this condition.</p> <p>2.4. Loose edges noted in the single ply material. If the edges are not properly sealed a roof leak may occur. Repairs are recommended.</p> <p>2.5. Nail pops were observed on the roof surface. This occurs when a roofing nail backs out of the wood sheathing causing the shingle above it to lift up. Nail pops make the shingles prone to wind damage, so repairs are recommended.</p> |

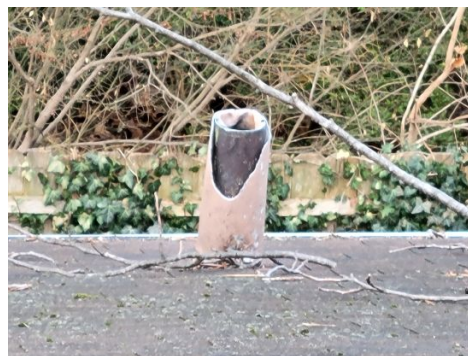
| Page 24 Item: 3 | Flashing | 3.1. Lead flashing is worn/damaged. Replacement flashing appears to be needed to eliminate the possibility of water penetration. |

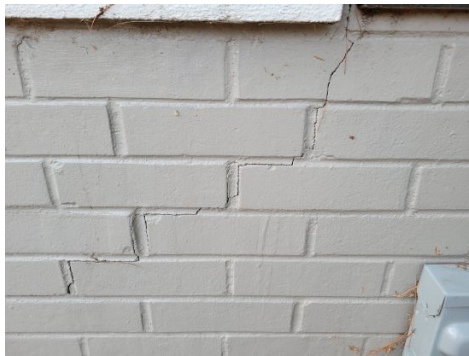
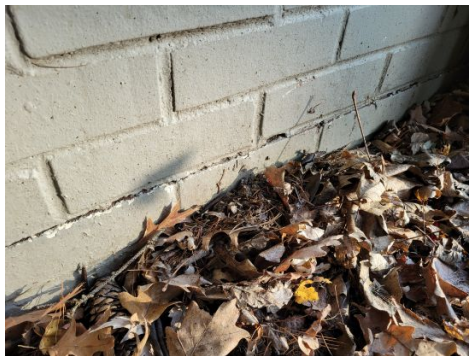
- 1.1. Cracked bricks/mortar noted. Further evaluation by a qualified brick mason is recommended and repairs made if necessary.
- 1.2. Loose siding observed. The siding should be properly secured to prevent damage and allow it protect the house.
- 1.3. Moisture damage noted on the wood, so further evaluation is recommended and repairs made as needed.
- 1.4. Peeling paint was observed, so paint repairs are recommended. If soft wood is discovered when preparing the surface for painting, replace the wood before painting.

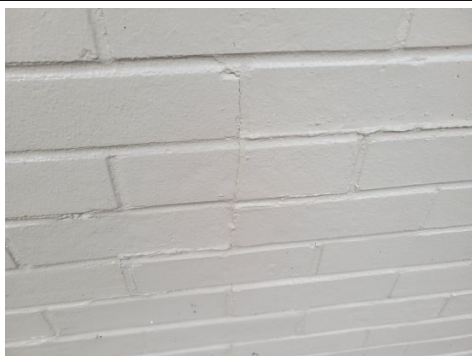
Page 27 Item: 2

2.1. Peeling paint was observed on this area. Paint repairs are recommended at this time to properly protect it from the elements. Soft wood may be discovered during the surface preparation. If so, wood repairs will need to be completed prior to the application of the finish coat of paint.

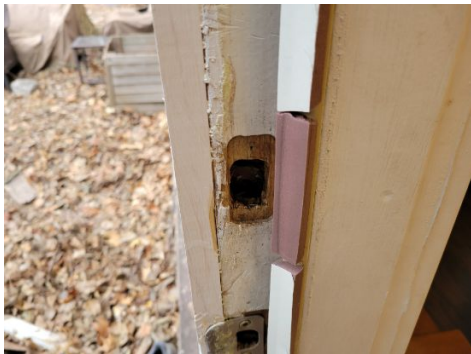
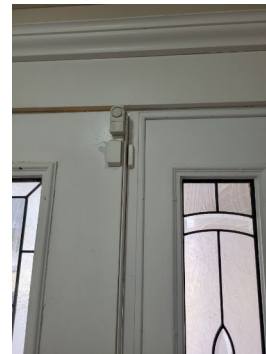
| Page 28 Item: 5 | Entry Doors | <p>5.1. Moisture damage was observed on the door jambs. Repairs are recommended to correct this condition.</p> <p>5.2. Missing strike plate noted for the deadbolt. Failure to install a strike plate can lead to door jamb damage, so strike plate installation is recommended at this time.</p> <p>5.3. Rubbing/sticking east door observed. Repairs are recommended to allow the door to open/close easily.</p> |

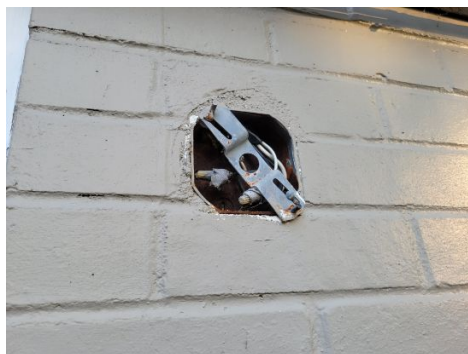
| Page 29 Item: 7 | Exterior Lighting | <p>7.2. Lighting fixture has been removed and the wires have not been terminated properly. A new light fixture should be installed or the wires properly terminated inside a covered junction box to prevent electrical shock or a potential fire. A qualified electrician is recommended to perform such repairs.</p> |

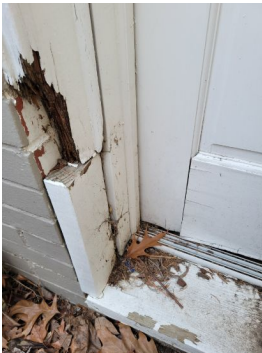
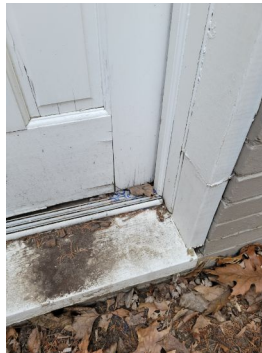
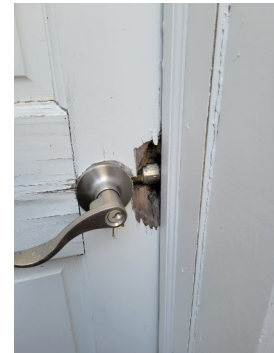
| Page 31 Item: 8 | Exterior Door | 8.2. Damage observed on the garage side door. Repairs/replacement of the affected door is recommended at this time.<br>8.3. Paint repairs appear to be needed at the trim, brick mold, and the door. Scraping/prep work should be completed prior to application of the paint. If any soft wood is encountered during the preparation portion of the paint job, wood repairs/replacement would need to be completed as well. |

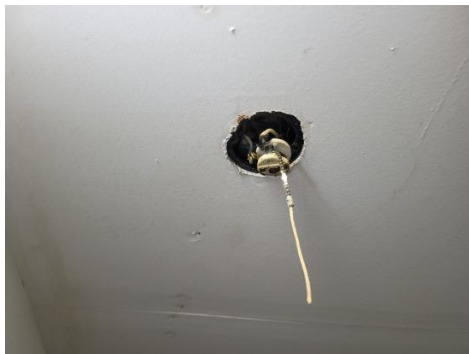
| Page 31 Item: 11 | Lights, Switches | 11.1. Broken light fixture observed in the room. A replacement fixture is needed to correct this deficiency. |

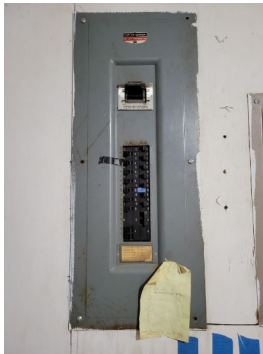
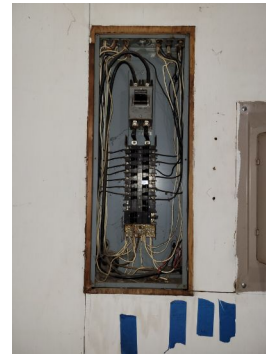
| Page 34 Item: 2 | Electric Service Panel | <p>2.1. Panel not completely labeled. All breakers should be labeled as a safety precaution.</p> <p>2.2. Missing 3 panel cover screws noted. Any missing screws should be replaced with blunt end screws to ensure that the panel is held securely in place.</p> |

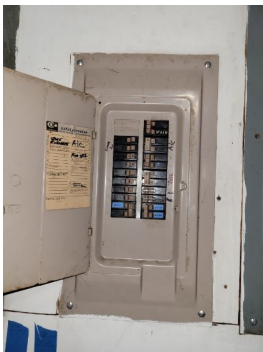
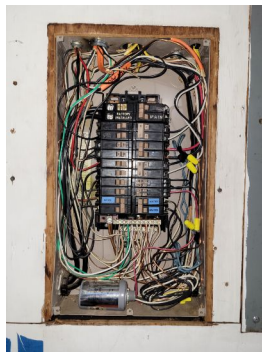
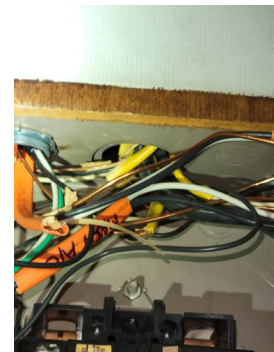
| Page 35 Item: 2 | Electric Service Panel | <p>2.1. Panel not completely labeled. All breakers should be labeled as a safety precaution.</p> <p>2.2. Missing wire clamp noted on the panel box. All cables entering the panel are supposed to enter through a clamp, known as a connector, to secure the wiring and protect the sheathing from damage.</p> |

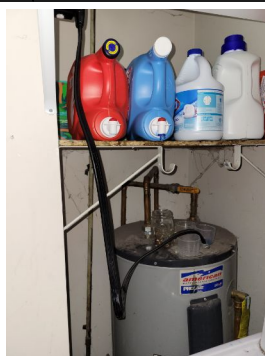
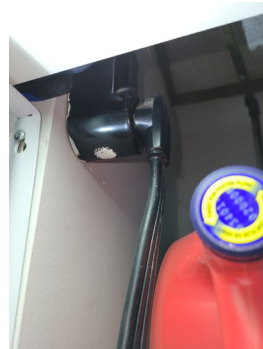
| Page 45 Item: 2 | Water Heater | <p>2.2. Improper use of a power cord to power the water heater. The water heater has a power cord plugged into an outlet which is improper since a power cord is only supposed to be used on appliances that need to be moved frequently for repair. The water heater should be hard-wired to a switch as the disconnect. Repairs are recommended.</p> |

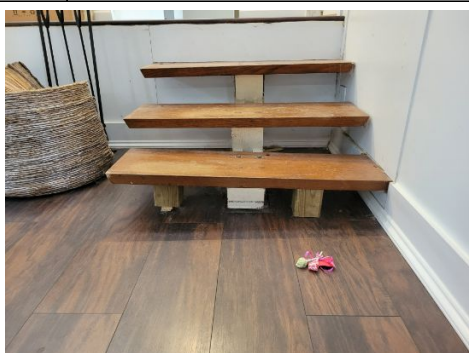
| Page 46 Item: 1 | Stairs/Handrails | <p>1.2. Uneven stair treads were noted at the stairway. This is a tripping hazard, so I recommend further evaluation and repairs by a qualified carpenter.</p> |

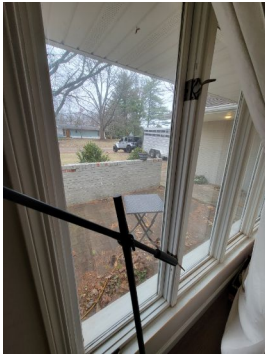
| Page 47 Item: 7 | Windows | 7.1. Stuck windows noted in the east room. Adjustments or repairs are recommended to restore the windows to an operational condition. Since windows also serve as a potential escape route, all windows should be kept in operational condition. |

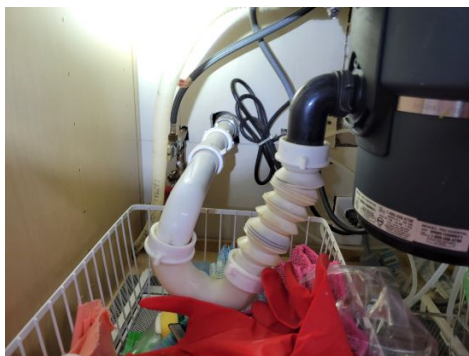
| Page 53 Item: 7 | Sink/Basin | 7.1. Flexible drain line in use on the drain line. Flexible drain lines are very susceptible to developing leaks and are, therefore, a poor and improper material for drain lines or traps. All drainage pipes and fittings should be smooth-wall material with no ridges, ledges or bends that will slow down or stop flow. Flexible material is unsanitary and has a greater tendency to clog. Further evaluation by a qualified plumber is recommended and repairs made as needed. |

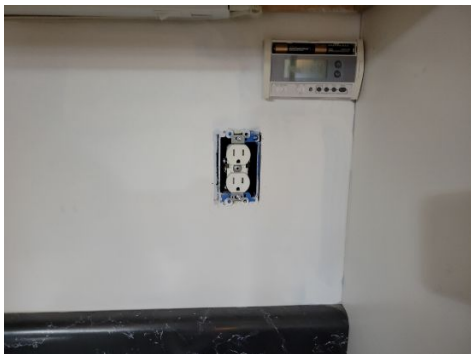
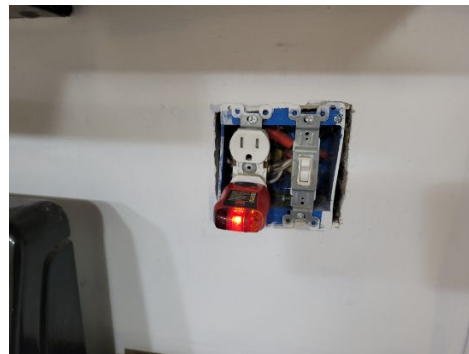
| Page 53 Item: 9 | Electrical | 9.3. Missing cover plates noted since the room is being painted. All switches and outlet boxes should have covers installed on them at all times as a safety precaution. A person can come into contact with energized electrical components, so replacing them once painting is completed is recommended. |

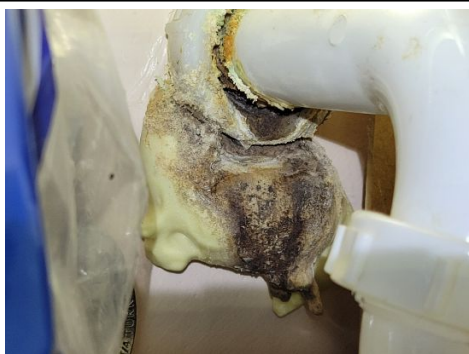
| Page 56 Item: 9 | Sink/Basin | <p>9.1. Low water flow was noted while testing the left faucet. Repairs are recommended to ensure adequate water flow is maintained at this unit. Further evaluation by a qualified plumber is recommended and repairs made as needed.</p> <p>9.2. Flexible drain line in use on the drain lines. Flexible drain lines are very susceptible to developing leaks and are, therefore, a poor and improper material for drain lines or traps. All drainage pipes and fittings should be smooth-wall material with no ridges, ledges or bends that will slow down or stop flow. Flexible material is unsanitary and has a greater tendency to clog. Further evaluation by a qualified plumber is recommended and repairs made as needed.</p> <p>9.3. Leaking drain lines noted under the sink. Repairs are needed to correct this condition.</p> |

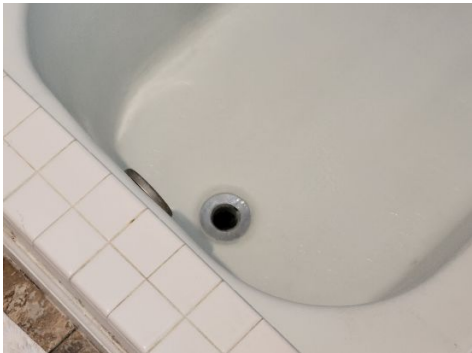
| Page 59 Item: 11 | Tub & Tub/Shower | 11.1. Missing tub stopper noted, so a replacement stopper is needed at this time. Due to this, the plumbing drains were not tested with our standard testing process. |

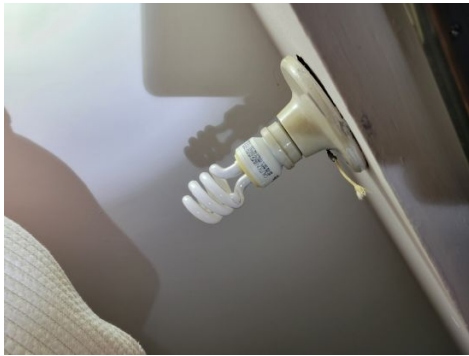
| Page 62 Item: 9 | Lights, Switches | <p>9.2. Inoperative closet light observed in the southwest bedroom. The pull chain did not operate the light when tested. The bulb should be replaced first and if the light still fails to operate, then further evaluation is needed and repairs made as necessary.</p> <p>9.3. Missing light bulb observed in the northwest bedroom closet, so the light was not tested. Replace the bulb and test the light to ensure it is functional.</p> |

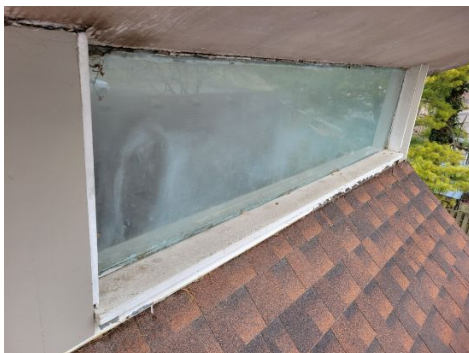
| Page 63 Item: 5 | Windows | <p>5.1. Fogged glass pane is present due to a broken seal. While a fogged glass pane does not allow water or air to pass through, it is a nuisance. Glass pane replacement is recommended to correct this problem, but not required.</p> <p>5.2. Fixed pane windows noted in this room which does not allow an escape route. Adding an escape route is recommended.</p> |

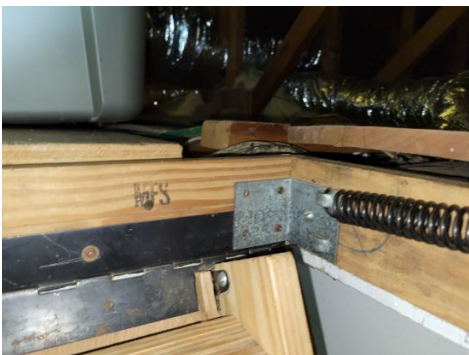
| Page 66 Item: 2 | Access | 2.1. Missing nails noted securing the stairs. Most pull down stairs require nails in the holes of the spring brackets for additional support, so add nails per manufacturer's guidelines.<br>2.2. Loose bracket noted at the top of the stairs, so repairs are recommended. |

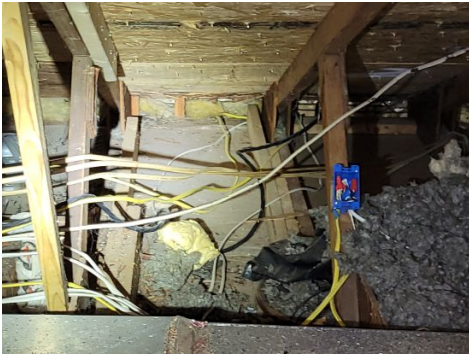
6.1. Insulation voids found using an Infrared camera and verified while inspecting the attic. Insulation installation is recommended.

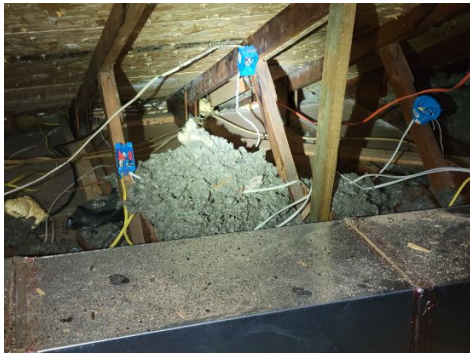
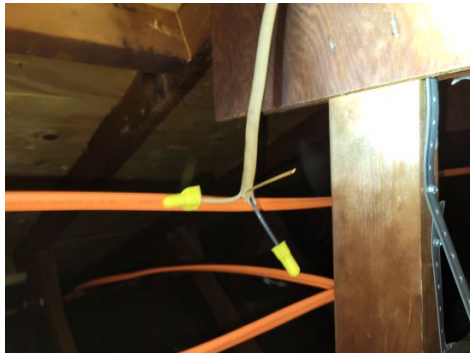
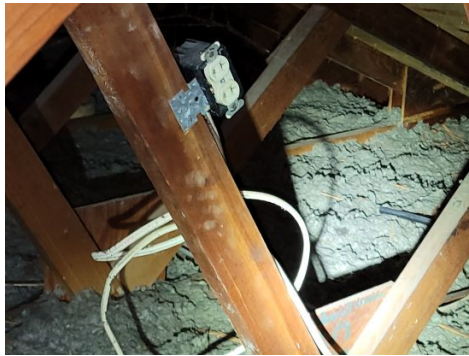
Page 68 Item: 8

8.1. Uncovered junction boxes observed which leaves the wiring susceptible to damage. Install a proper cover on each box to correct this deficiency. Not all of the boxes may be pictured.

8.2. Improper wire terminations observed. All wire terminations should be contained in a properly sized, securely mounted, covered junction box. Repairs are recommended as a safety precaution.

8.3. Missing cover plate noted. All switches and outlet boxes should have covers installed on them at all times as a safety precaution. If not repaired, a person can come into contact with energized electrical components.

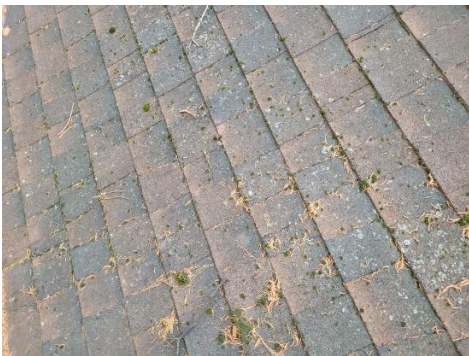
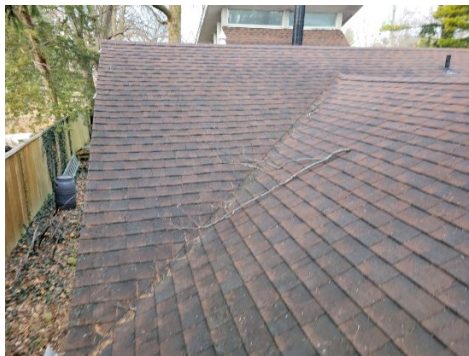
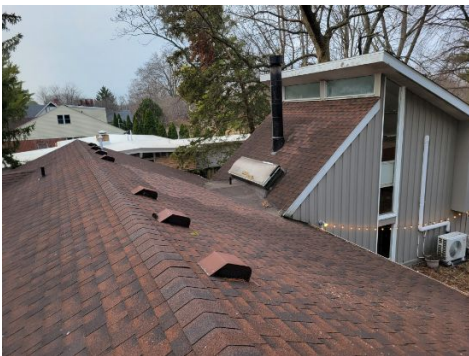
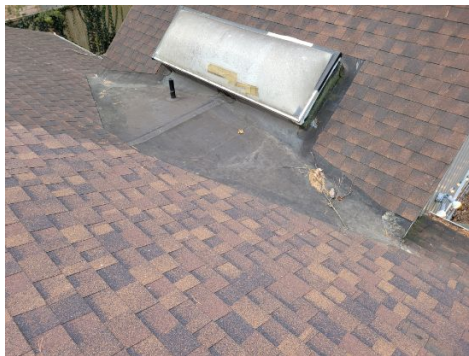
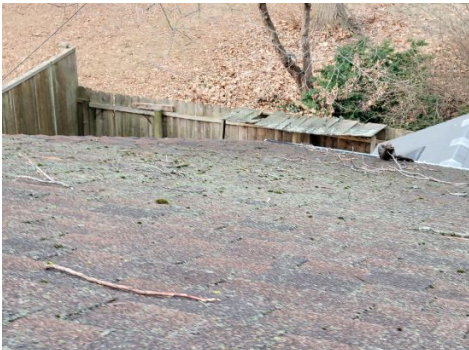
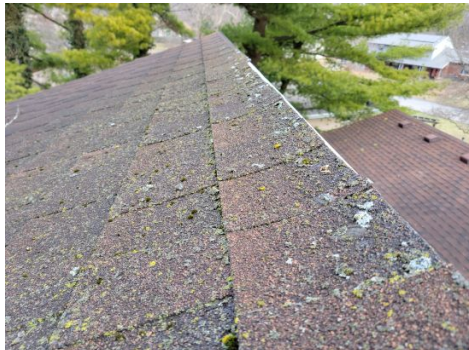
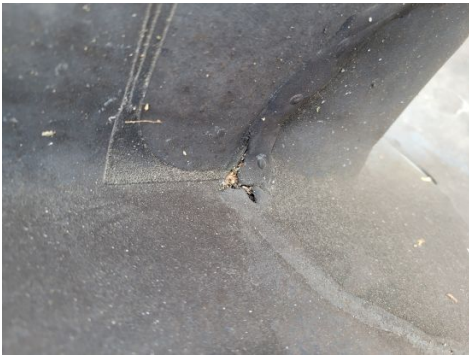
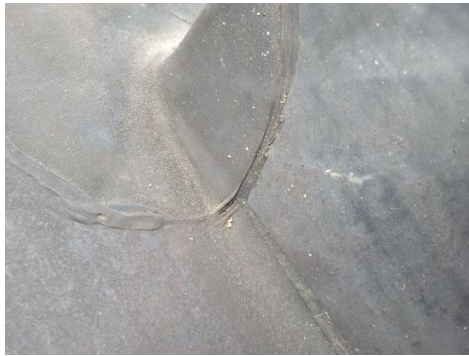
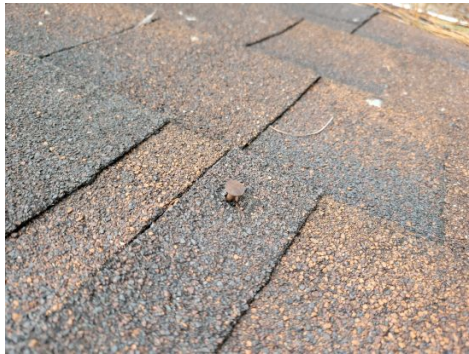
2.3. Moss growth noted on the roofing surface. Moss growth deteriorates the roofing material and will eventually cause a roof leak to occur. All moss growth should be gently cleaned from the roof. Chemical treatments are available to help reduce the reoccurrence of this condition.

2.4. Loose edges noted in the single ply material. If the edges are not properly sealed a roof leak may occur. Repairs are recommended.

2.5. Nail pops were observed on the roof surface. This occurs when a roofing nail backs out of the wood sheathing causing the shingle above it to lift up. Nail pops make the shingles prone to wind damage, so repairs are recommended.

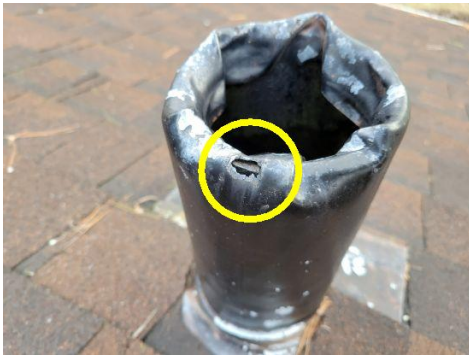
3.1. Lead flashing is worn/damaged. Replacement flashing appears to be needed to eliminate the possibility of water penetration.

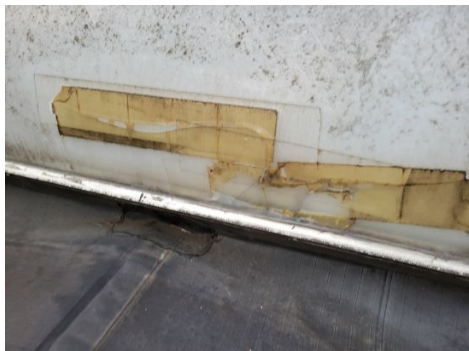
4.2. Plastic is heavily cracked but does not appear to be leaking. Monitor and replace on an as needed basis.

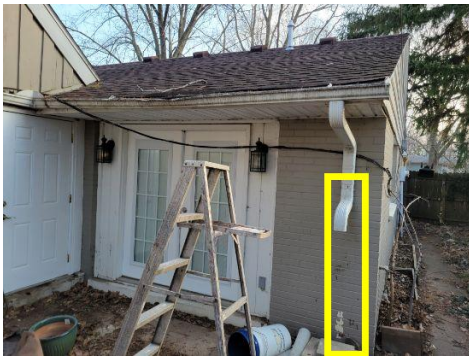
7.3. Missing downspout section was observed, so replace the missing section to ensure proper drainage away from the foundation.

7.4. Sagging gutter noted. Repairs are recommended to ensure proper drainage.

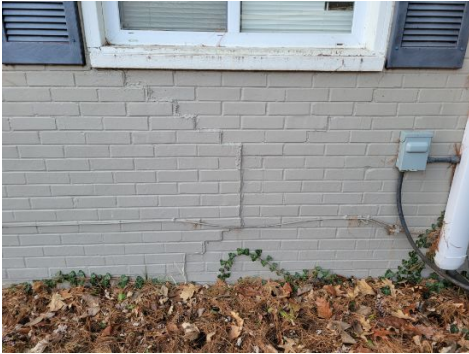
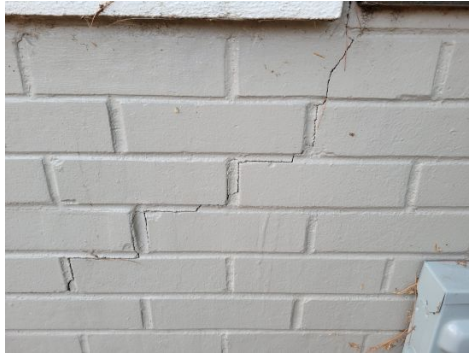
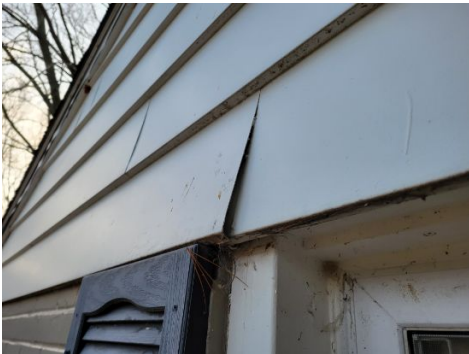
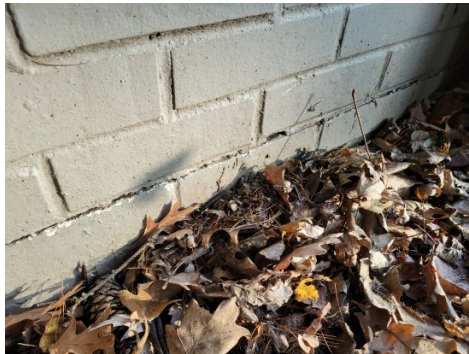
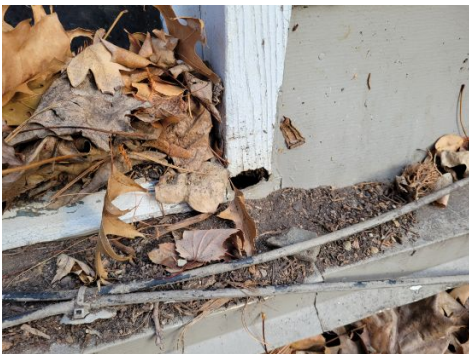
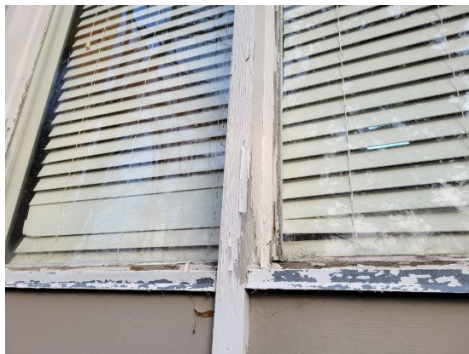
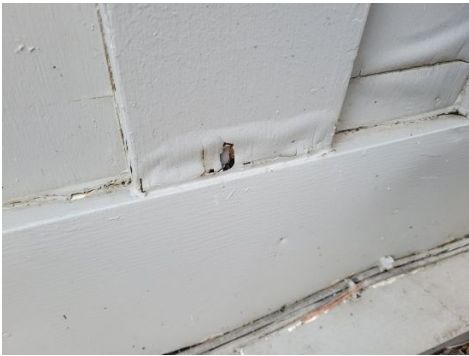
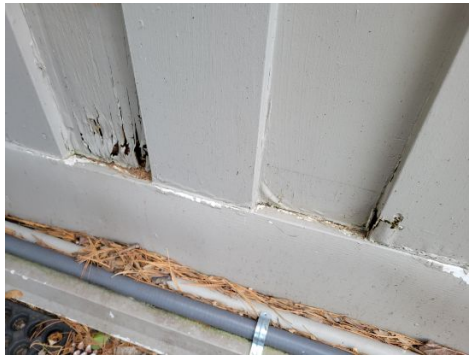
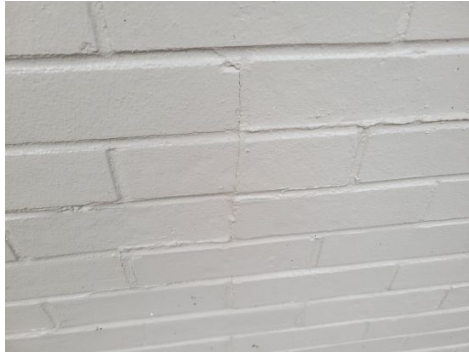
- 1.1. Cracked bricks/mortar noted. Further evaluation by a qualified brick mason is recommended and repairs made if necessary.
- 1.2. Loose siding observed. The siding should be properly secured to prevent damage and allow it protect the house.
- 1.3. Moisture damage noted on the wood, so further evaluation is recommended and repairs made as needed.
- 1.4. Peeling paint was observed, so paint repairs are recommended. If soft wood is discovered when preparing the surface for painting, replace the wood before painting.

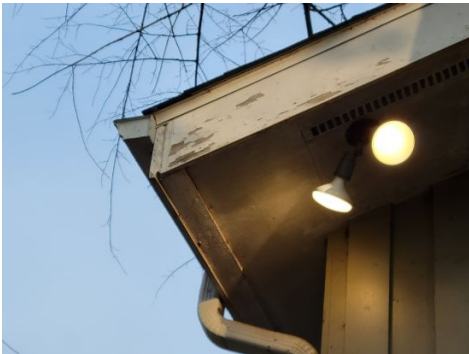
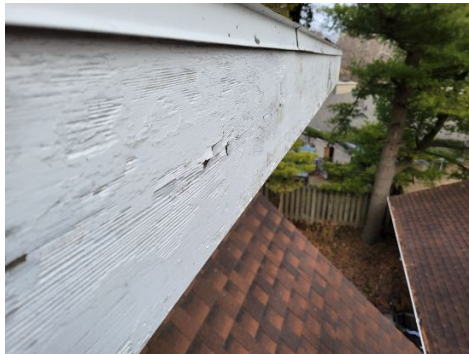
2.1. Peeling paint was observed on this area. Paint repairs are recommended at this time to properly protect it from the elements. Soft wood may be discovered during the surface preparation. If so, wood repairs will need to be completed prior to the application of the finish coat of paint.

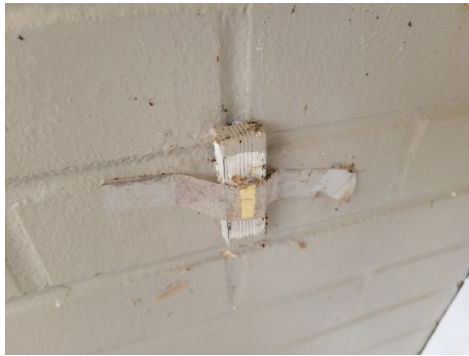
4.1. Doorbell button was taped and not tested. Testing is recommended.

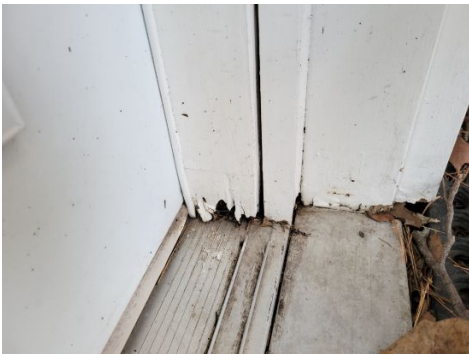
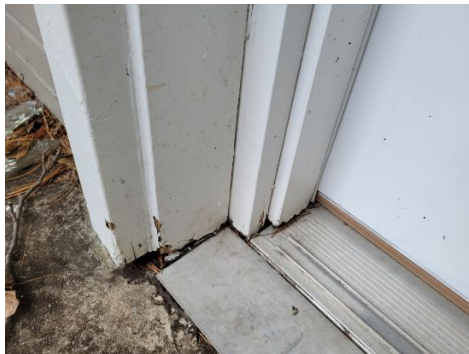
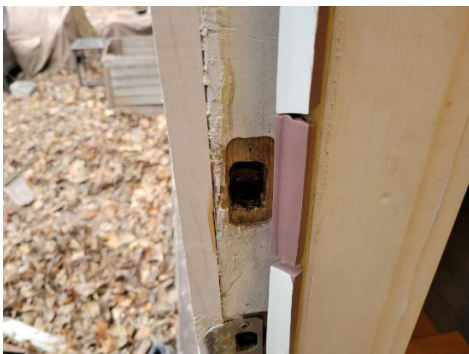
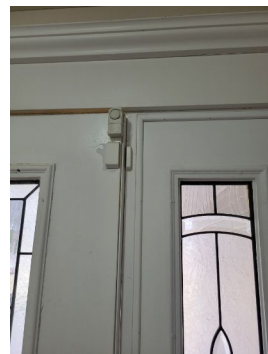
5.1. Moisture damage was observed on the door jambs. Repairs are recommended to correct this condition.

5.2. Missing strike plate noted for the deadbolt. Failure to install a strike plate can lead to door jamb damage, so strike plate installation is recommended at this time.

5.3. Rubbing/sticking east door observed. Repairs are recommended to allow the door to open/close easily.

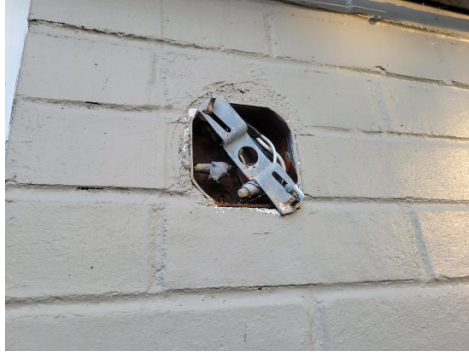
7.2. Lighting fixture has been removed and the wires have not been terminated properly. A new light fixture should be installed or the wires properly terminated inside a covered junction box to prevent electrical shock or a potential fire. A qualified electrician is recommended to perform such repairs.

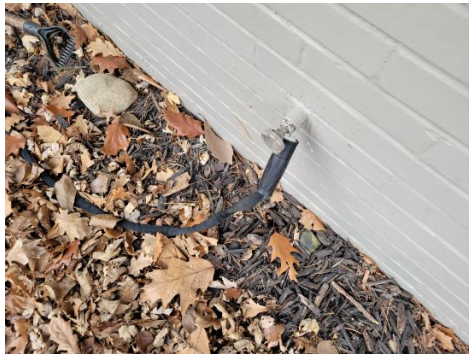
8.1. The front faucet handle will not turn, making the faucet not operational. Further evaluation is recommended, and repairs made on an as needed basis.

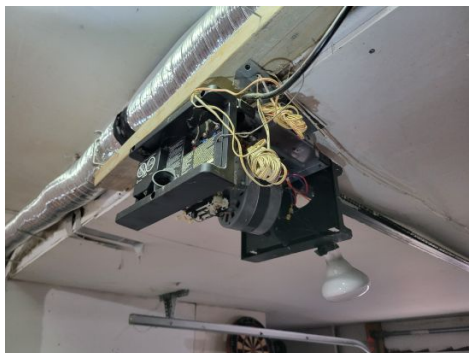
3.1. Inoperative at time of inspection. Repairs or possibly a new unit is needed to restore this system to a properly operating condition.

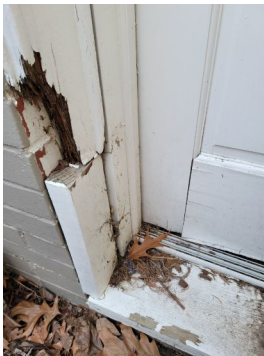
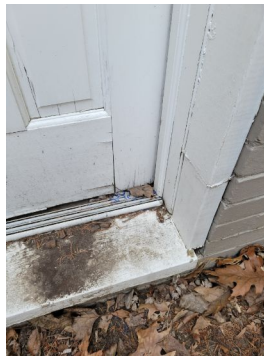
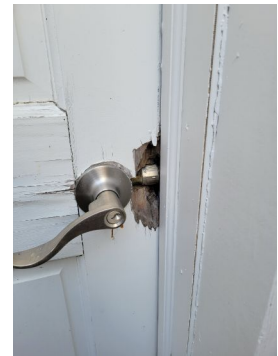
8.2. Damage observed on the garage side door. Repairs/replacement of the affected door is recommended at this time.

8.3. Paint repairs appear to be needed at the trim, brick mold, and the door. Scraping/prep work should be completed prior to application of the paint. If any soft wood is encountered during the preparation portion of the paint job, wood repairs/replacement would need to be completed as well.

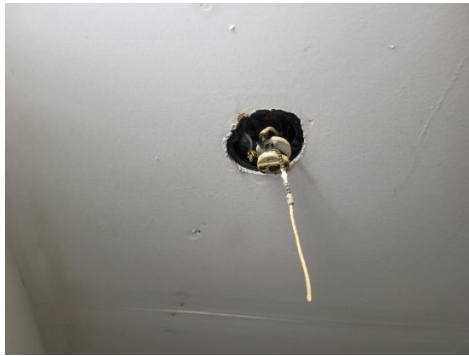
11.1. Broken light fixture observed in the room. A replacement fixture is needed to correct this deficiency.

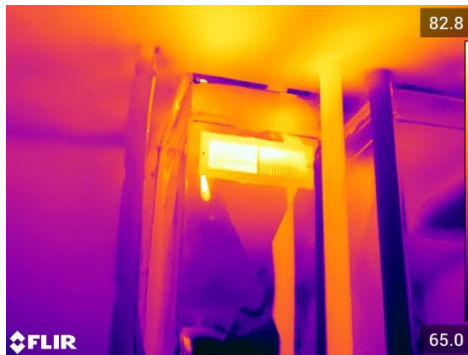
12.1. Register observed, which is connected to the house HVAC system. This has been prohibited since 1983 since fumes from the garage can enter the living space. Sealing the register or removing it is recommended.

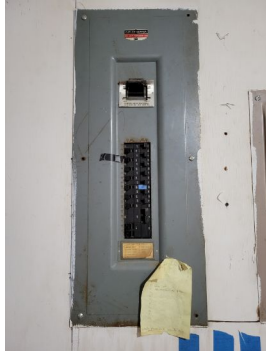
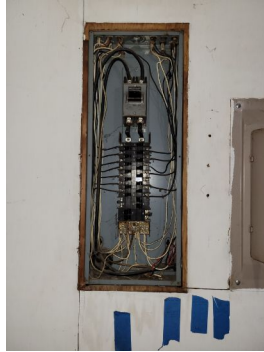
2.1. Panel not completely labeled. All breakers should be labeled as a safety precaution.

2.2. Missing 3 panel cover screws noted. Any missing screws should be replaced with blunt end screws to ensure that the panel is held securely in place.

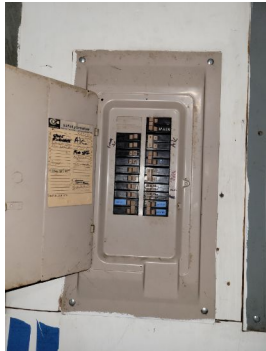
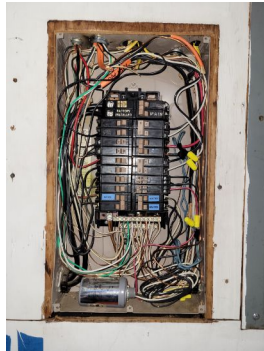
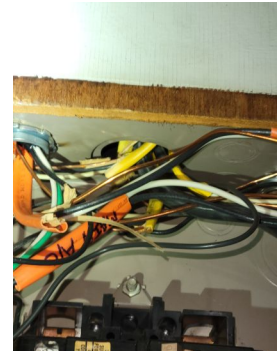
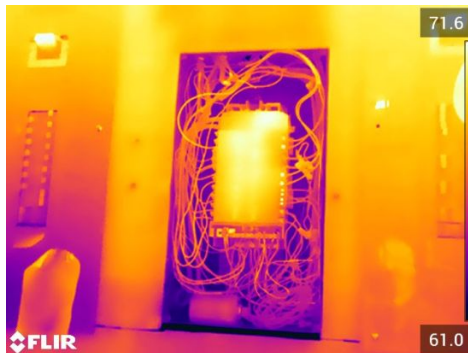
2.1. Panel not completely labeled. All breakers should be labeled as a safety precaution.

2.2. Missing wire clamp noted on the panel box. All cables entering the panel are supposed to enter through a clamp, known as a connector, to secure the wiring and protect the sheathing from damage.

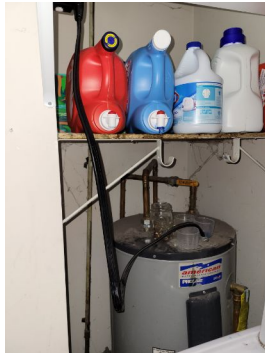
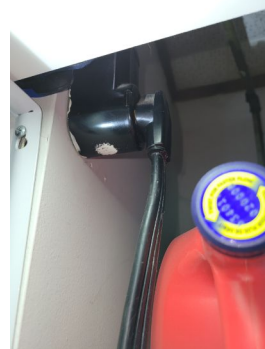
2.1. Water heater is located in the laundry room

2.2. Improper use of a power cord to power the water heater. The water heater has a power cord plugged into an outlet which is improper since a power cord is only supposed to be used on appliances that need to be moved frequently for repair. The water heater should be hard-wired to a switch as the disconnect. Repairs are recommended.

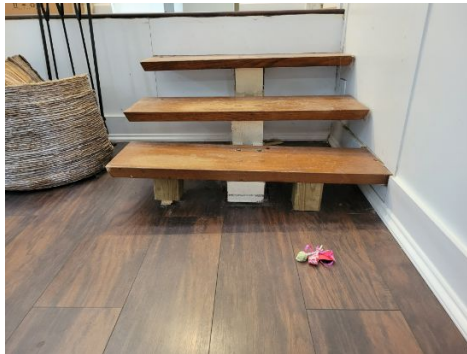
1.1. Upgrading the handrail to today's standards is recommended. That may include enclosing openings to meet the 4" rule or having a grippable handrail that is continuous from bottom to the top and turns back into the wall.

1.2. Uneven stair treads were noted at the stairway. This is a tripping hazard, so I recommend further evaluation and repairs by a qualified carpenter.

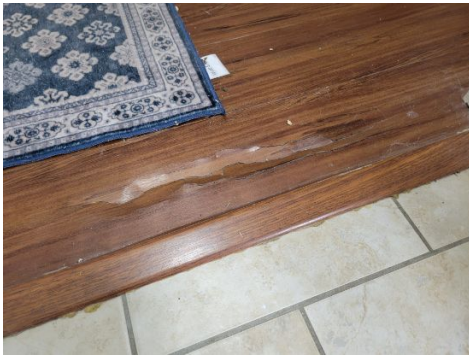
4.1. Damaged flooring material observed. Flooring repairs are recommended.

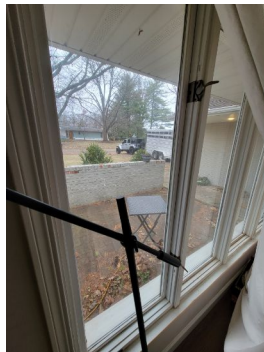
7.1. Stuck windows noted in the east room. Adjustments or repairs are recommended to restore the windows to an operational condition. Since windows also serve as a potential escape route, all windows should be kept in operational condition.

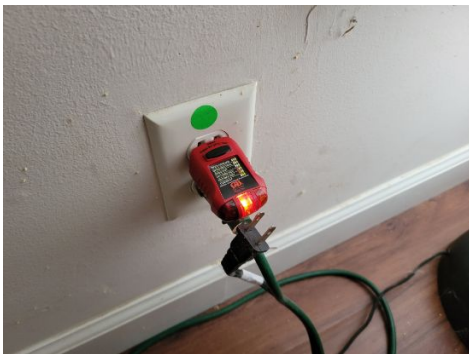
8.1. Open ground condition found on many of the outlets in this house. This condition is common due to the wiring, hot & neutral wires only, used during the time period the house was constructed and the desire to change or decorate for modern times. The house's original 2-prong non grounded outlets have been replaced with a 3-prong outlet but a ground wire doesn't exist which causes the issue. Just because an electric panel has been upgraded and some wiring has been changed does not guarantee that all of the wiring has been replaced with wiring that includes a ground wire. The wiring is still safe, but is identified in the report since some appliances (refrigerators, microwaves, surge protectors, desk top computers, clothes washers, etc.) do need the ground to be functional in the outlet to work safely/properly. In most cases, the 3-prong outlets have been installed out of convenience and/or cost and we are identifying the condition for you since you can not tell if it is grounded by looking at it. A 2-prong outlet is harder to find and usually costs 4 times the price of a 3-prong outlet which makes it the choice of most homeowners changing outlets. Replacing the 3-prong outlets with a 2-prong or GFCI outlets is usually the proper solution.

Areas around water where a GFCI is recommended will still show up in the detail as open ground.

Not all instances pictured

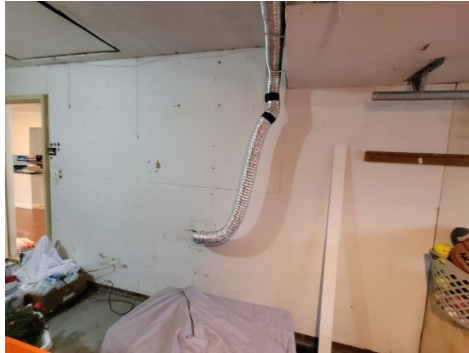
12.1. Dryer vent appeared serviceable at time of inspection.

12.2. If you choose to use the gas hookup, the venting material should be changed to either rigid or corrugated metal vent lines as a safety precaution. Gas dryers vent carbon monoxide, as well as lint and moisture, through the vent. Plastic or aluminum foil flex is very susceptible to damage/holes thus allowing the gases inside the structure.

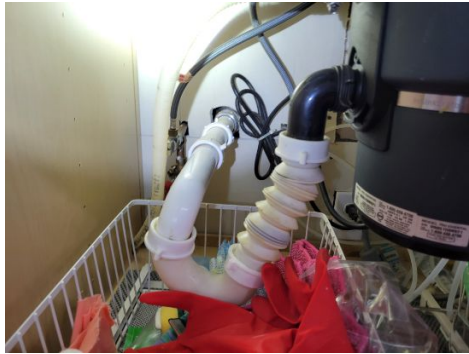
7.1. Flexible drain line in use on the drain line. Flexible drain lines are very susceptible to developing leaks and are, therefore, a poor and improper material for drain lines or traps. All drainage pipes and fittings should be smooth-wall material with no ridges, ledges or bends that will slow down or stop flow. Flexible material is unsanitary and has a greater tendency to clog. Further evaluation by a qualified plumber is recommended and repairs made as needed.

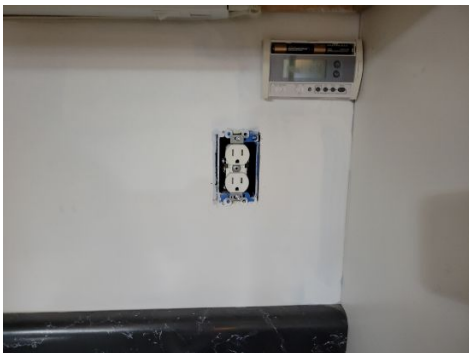
9.2. Open grounds noted at some 3 prong outlets. Any 3-prong outlet installed in a house is supposed to be properly grounded. Repairs are recommended to correct this condition.

9.3. Missing cover plates noted since the room is being painted. All switches and outlet boxes should have covers installed on them at all times as a safety precaution. A person can come into contact with energized electrical components, so replacing them once painting is completed is recommended.

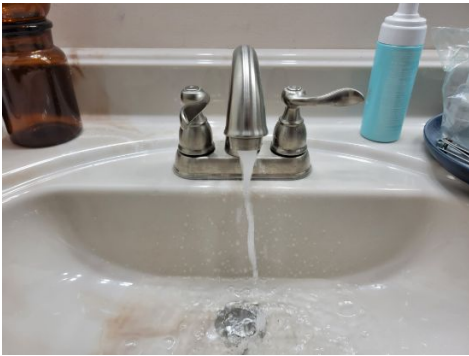
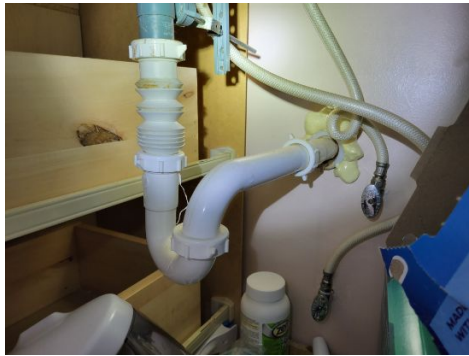
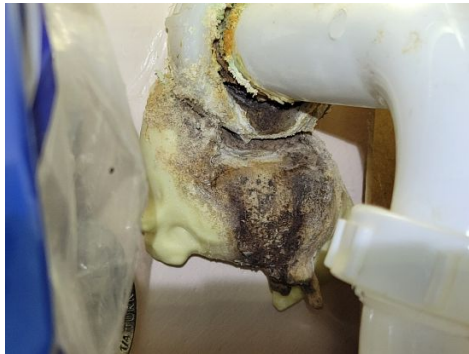
9.1. Low water flow was noted while testing the left faucet. Repairs are recommended to ensure adequate water flow is maintained at this unit. Further evaluation by a qualified plumber is recommended and repairs made as needed.

9.2. Flexible drain line in use on the drain lines. Flexible drain lines are very susceptible to developing leaks and are, therefore, a poor and improper material for drain lines or traps. All drainage pipes and fittings should be smooth-wall material with no ridges, ledges or bends that will slow down or stop flow. Flexible material is unsanitary and has a greater tendency to clog. Further evaluation by a qualified plumber is recommended and repairs made as needed.

9.3. Leaking drain lines noted under the sink. Repairs are needed to correct this condition.

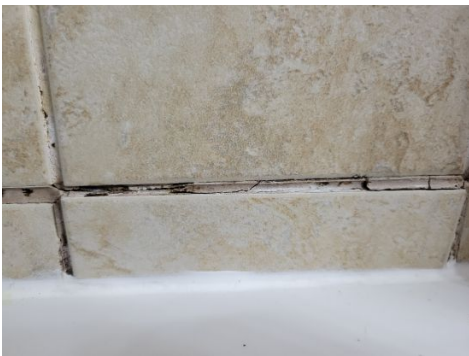
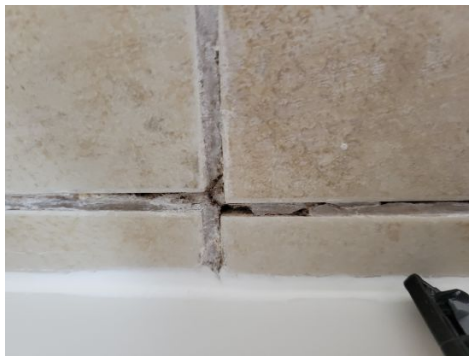
11.2. Loose tile and cracked mortar observed around the tub. Tile repairs are recommended to ensure water damage does not occur to the areas behind the tile.

11.3. Missing tub stopper noted, so a replacement stopper is needed at this time. Due to this, the plumbing drains were not tested with our standard testing process.

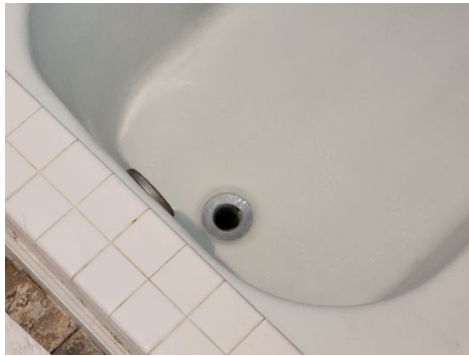
11.1. Missing tub stopper noted, so a replacement stopper is needed at this time. Due to this, the plumbing drains were not tested with our standard testing process.

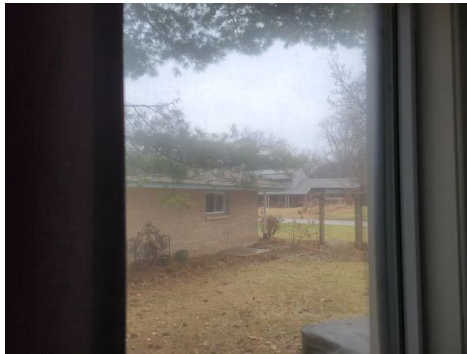
6.1. Bottom sash falls down when released and will not stay open. Repairs are recommended to allow the window to function properly.

6.2. Fogged glass pane is present in the northwest bedroom due to a broken seal. While a fogged glass pane does not allow water or air to pass through, it is a nuisance. Glass pane replacement is recommended to correct this problem, but not required.

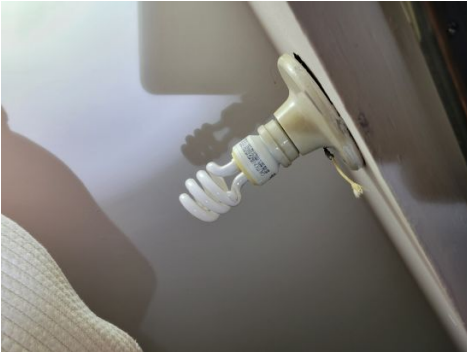
9.2. Inoperative closet light observed in the southwest bedroom. The pull chain did not operate the light when tested. The bulb should be replaced first and if the light still fails to operate, then further evaluation is needed and repairs made as necessary.

9.3. Missing light bulb observed in the northwest bedroom closet, so the light was not tested. Replace the bulb and test the light to ensure it is functional.

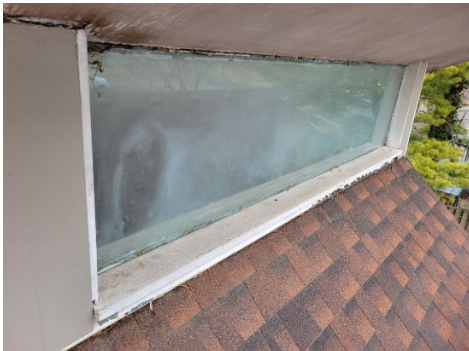
5.1. Fogged glass pane is present due to a broken seal. While a fogged glass pane does not allow water or air to pass through, it is a nuisance. Glass pane replacement is recommended to correct this problem, but not required.

5.2. Fixed pane windows noted in this room which does not allow an escape route. Adding an escape route is recommended.

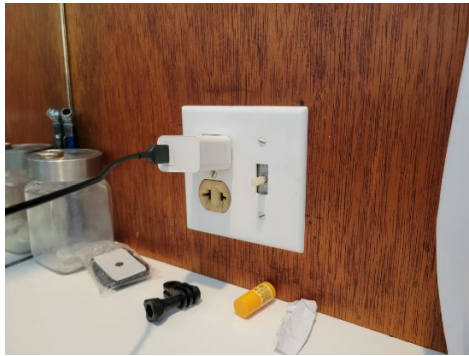
8.2. Missing dimmer knob. Replacement knob is recommended to allow easy control of the light.

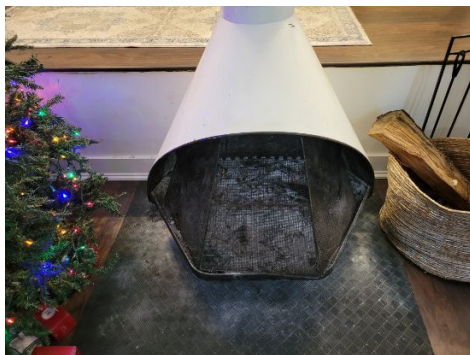
1.1. General condition is consistent with age and use.

1.2. Operation Note: If you burn wood in the fireplace more than six times in a year, you should have it professionally cleaned annually. If you burn fires six or less times, clean the unit every 2 years as a safety precaution.

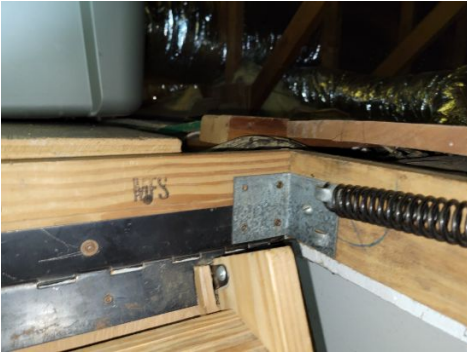
2.1. Missing nails noted securing the stairs. Most pull down stairs require nails in the holes of the spring brackets for additional support, so add nails per manufacturer's guidelines.

2.2. Loose bracket noted at the top of the stairs, so repairs are recommended.

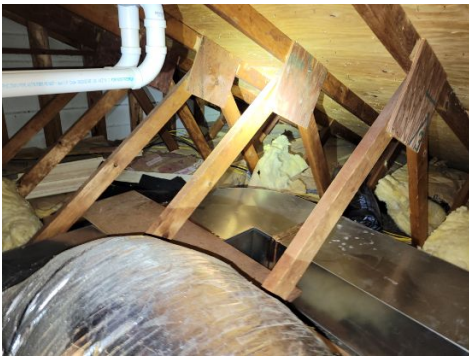
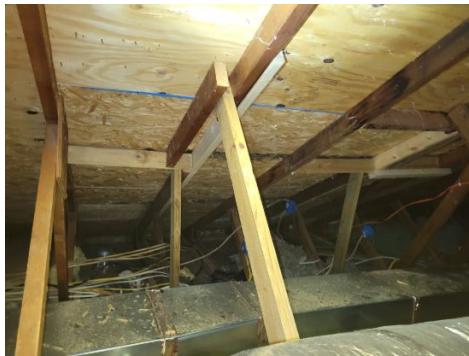
3.1. Modified wood trusses observed. The inner web has been cut/moved on the trusses in the main portion of the attic. On this type of framing system, no modifications are typically permitted per the manufacturer's specifications. Further evaluation by a qualified carpenter is recommended and repairs made as needed.

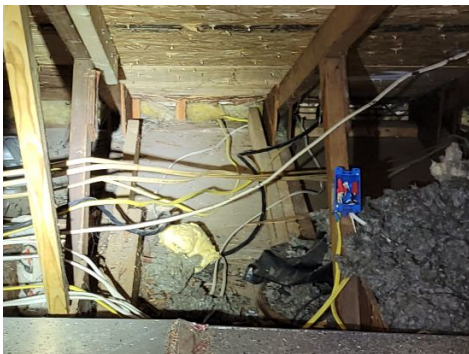
6.1. Insulation voids found using an Infrared camera and verified while inspecting the attic.

Insulation installation is recommended.

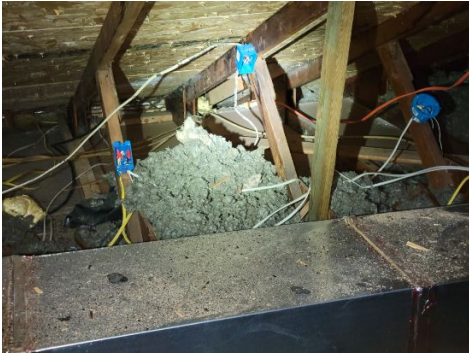
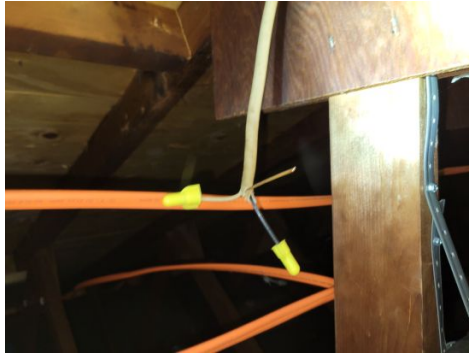
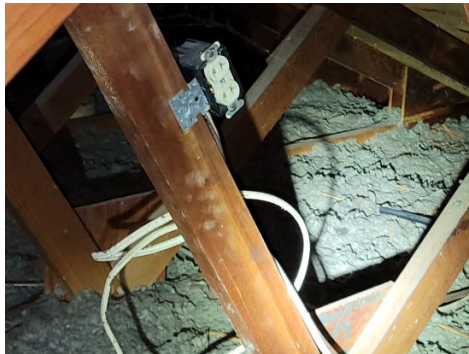
- 8.1. Uncovered junction boxes observed which leaves the wiring susceptible to damage. Install a proper cover on each box to correct this deficiency. Not all of the boxes may be pictured.
- 8.2. Improper wire terminations observed. All wire terminations should be contained in a properly sized, securely mounted, covered junction box. Repairs are recommended as a safety precaution.
- 8.3. Missing cover plate noted. All switches and outlet boxes should have covers installed on them at all times as a safety precaution. If not repaired, a person can come into contact with energized electrical components.

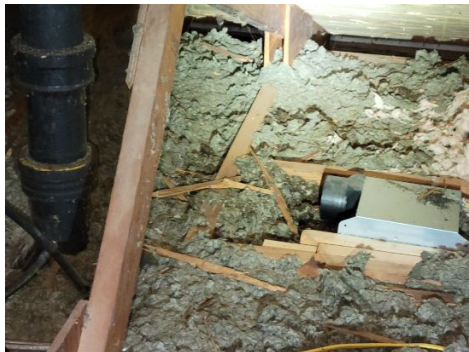
- 9.1. Bathroom fan currently vents directly into the attic, not the exterior of the house. This type of venting can cause moisture damage within the attic. All bath fans are now recommended to vent to the exterior of the house as a mold and moisture prevention measure. Routing the vents to the exterior may not have been 'required' when this house was constructed, but is now recommended as an "upgrade".

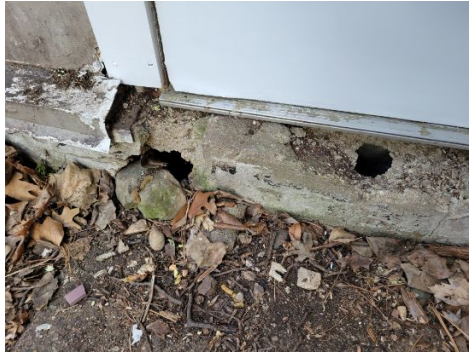
2.1. Damaged block observed on the wall of the foundation. A qualified brick mason should be contacted to provide further inspection and repairs made as needed.
